HOME INSPECTION REPORT

123 Curzon St

Toronto

Inspection Date: April 25 2017

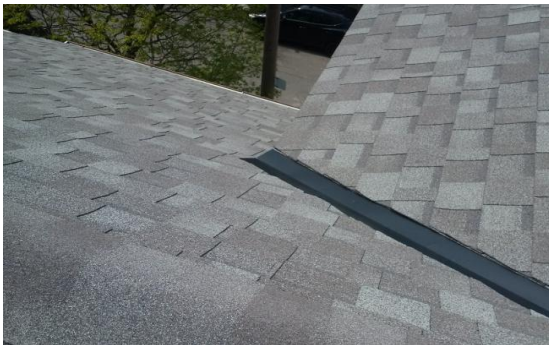
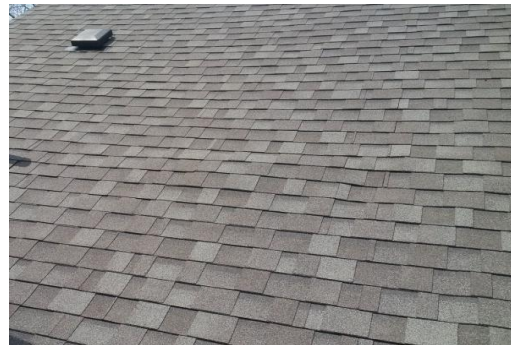
Sloped Surface: overall surface in good repair

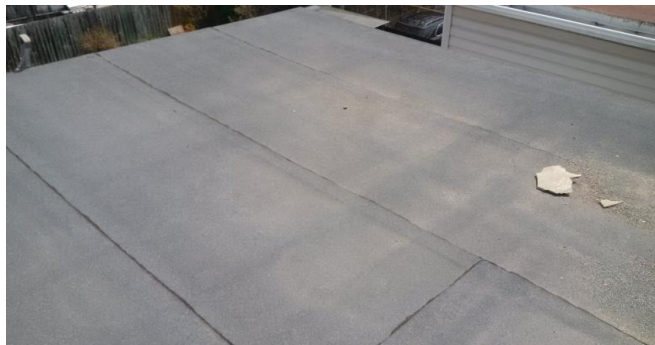
Flat Surface: overall surface in good repair

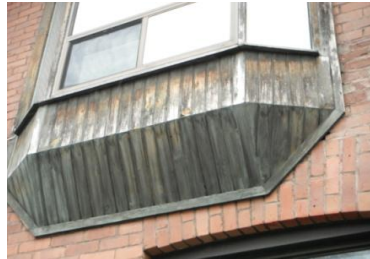
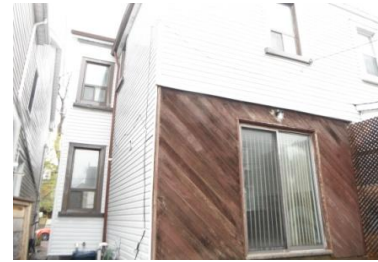
Wood siding: requires general repairs and maintenance

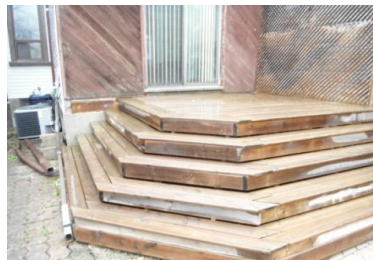
DECK overall in good repair, provide rails for safety

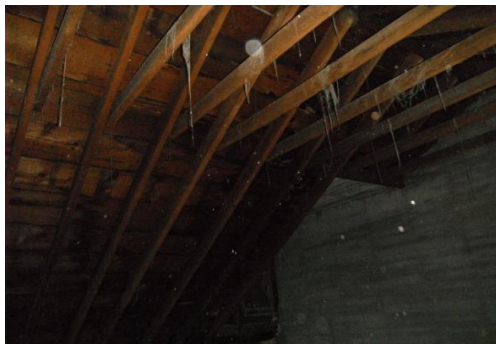
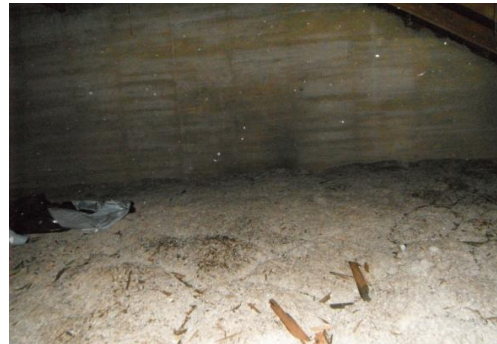
Party Walls: seal opening in wall on northeast side of roof

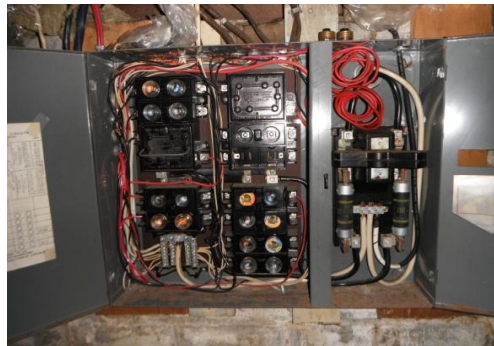
Main Disconnect: **older, upgrade if renovating**
SERVICE PANEL: **older, upgrade if renovating**
some overfused units - provide proper fuse size

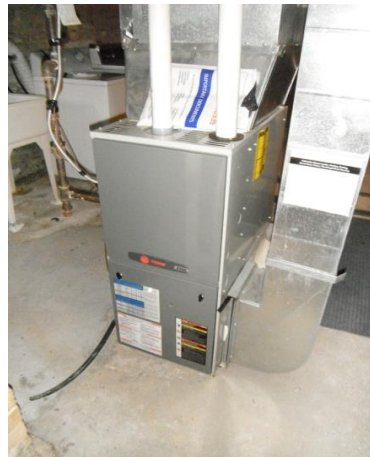
FORCED AIR FURNACE: [service annually](#)
Humidifier: [service unit](#)

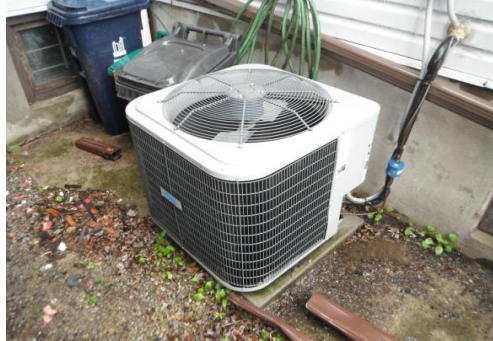
AIR CONDITIONER: not tested: should be serviced before using

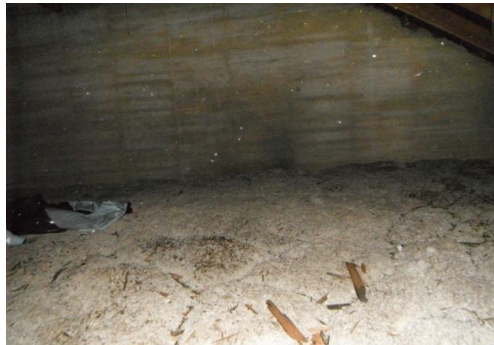
ROOF SPACE: [insulation has been upgraded](#)

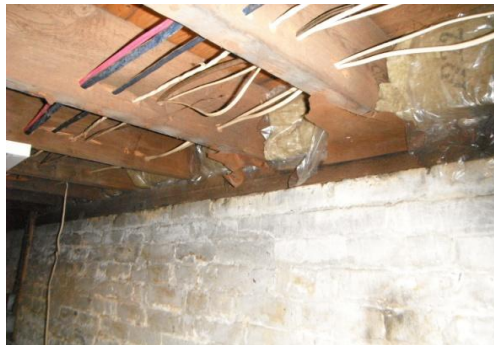
Basement Walls: [the headers have been insulated to reduce heat loss](#)

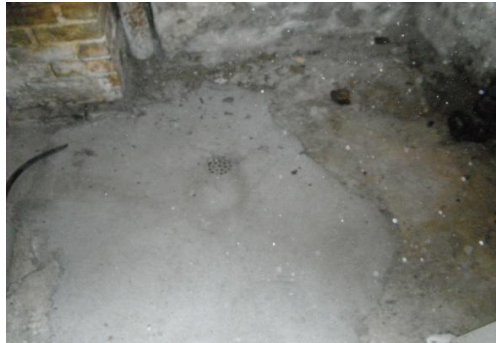
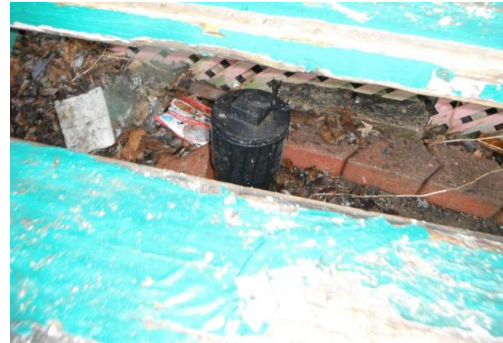
Piping: portion of drains in basement floor have been replaced, new cleanout at front under porch suggests upgraded waste drain to city sewer

Basement Floor Drain: unit has been replaced as noted above
