HOME INSPECTION REPORT

128 Angier Cres

Toronto

Inspection Date: July 31 2015

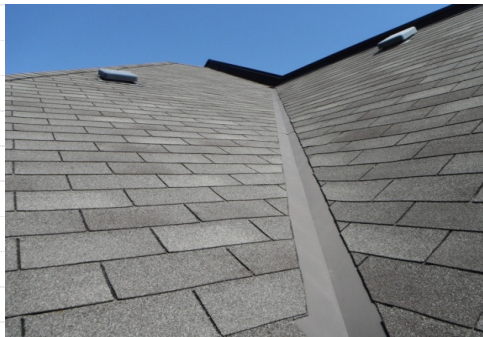
Roofing:
Sloped Surface: overall surface in good repair

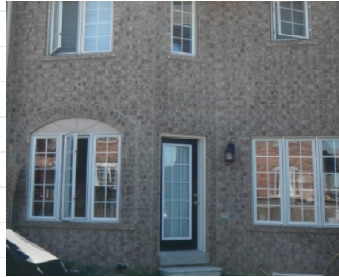
WALL SURFACES: overall well maintained

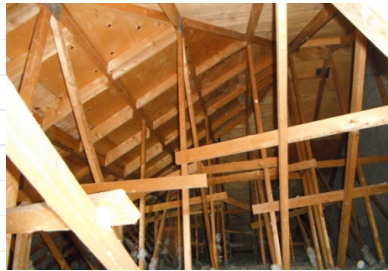
ROOF: overall in good repair

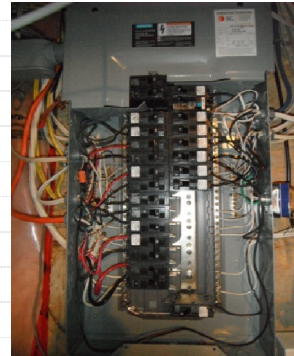
SERVICE PANEL: **overall in good repair**
 Double-Taps: **some units - not critical- add more breakers if required**

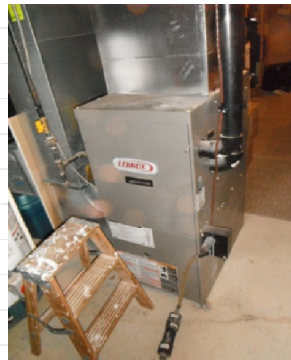
FORCED AIR FURNACE: [service annually](#)

[power switch for unit should be properly secured](#)

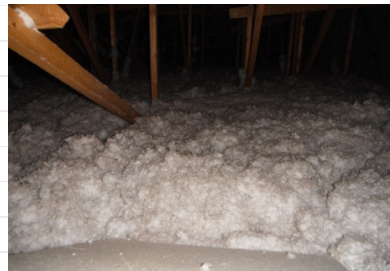
ROOF SPACE: insulation and ventilation is adequate
