# HOME INSPECTION REPORT

16 Norwood Terrace

Toronto

Inspection Date: Nov 19 2015

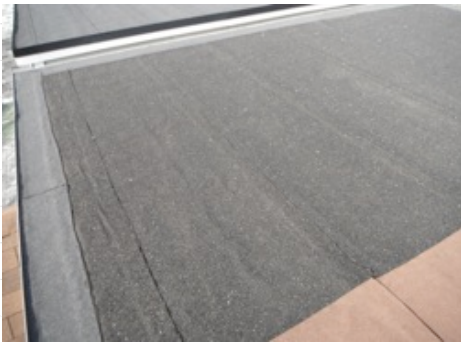
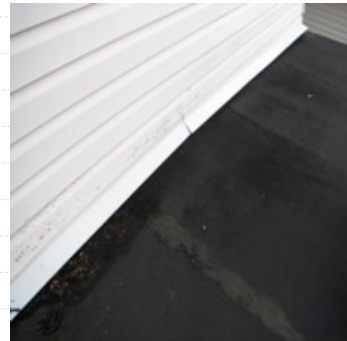
Flat Surface: [overall surface in good repair](#)  
 Upper Flat: [ponding against wall - monitor and re-grade if required](#)

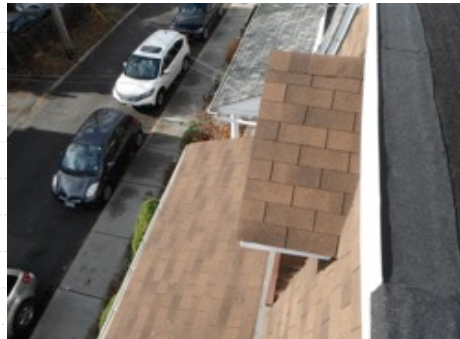
Sloped Surface: [overall surface in good repair](#)

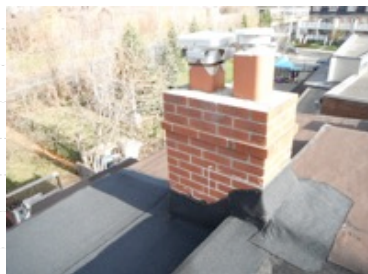
Chimney(s): [overall in good repair](#)

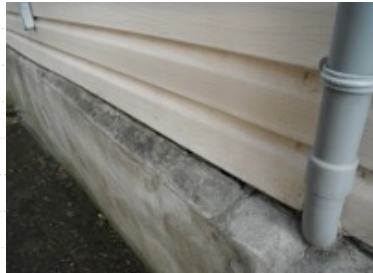
WALL SURFACES: top of foundation requires cap with drip edge to reduce moisture on foundation  
exposed framing at rear corner requires repair

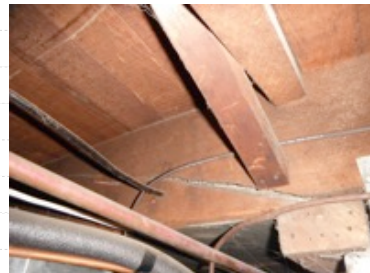
Joists: split unit in basement central - should be reinforced, minor splitting noted on other joists though not critical

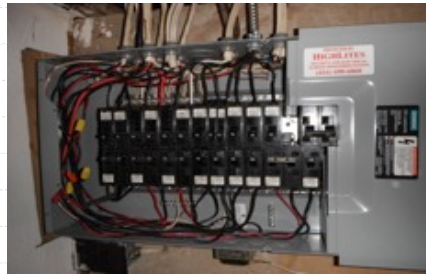
SERVICE PANEL: **overall in good repair**

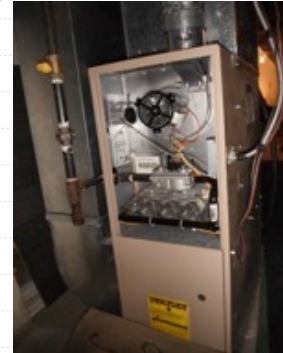
FORCED AIR FURNACE: [continue servicing until replacement becomes necessary](#)  
Humidifier: [remove and/or replace](#)

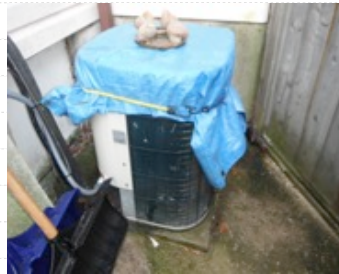
AIR CONDITIONER: [old unit, continue servicing until replacement becomes necessary](#)

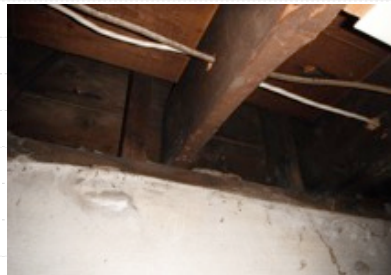
Rim Joists: basement top perimeter- recommend insulation and covering with drywall, this to reduce heat loss and to suppress fire spread
