HOME INSPECTION REPORT

163 Shanly St

Prepared by: Bob Papadopoulos P.Eng., RHI *

Inspection Date: May 27 2022

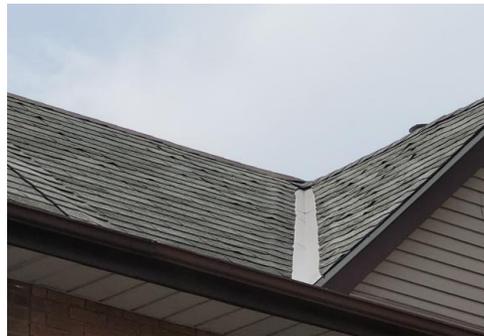
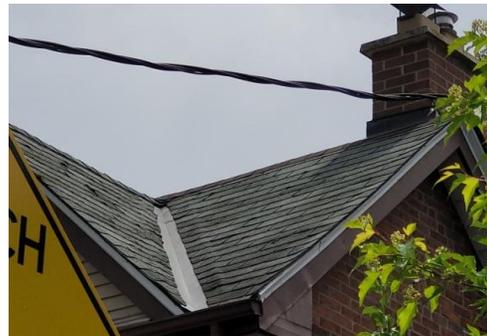
Sloped Surface: overall surface in good repair
aging surface, budget to replace within 5yrs.

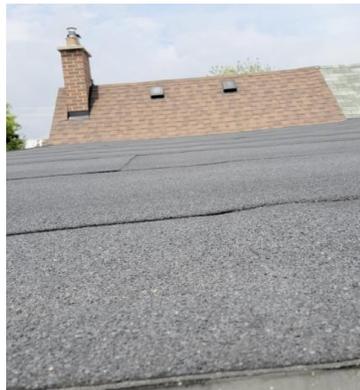
Flat Surface: overall in good repair
rebuilt and in good repair

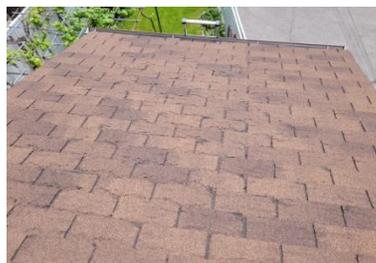
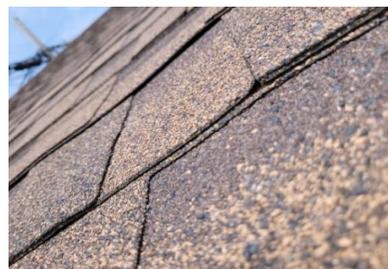
2nd Slope: aging surface, budget to replace within 3 yrs.
Garage: overall surface in good repair

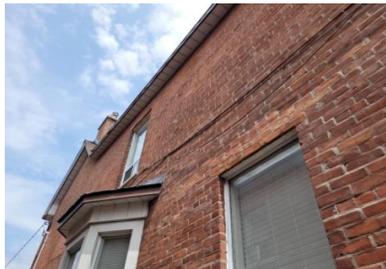
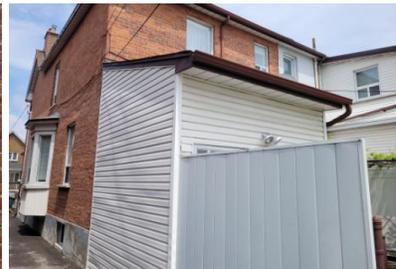
** Downspouts: extend 6-ft away from house
 WALL SURFACES: overall in good repair, minor brick surface spalling
 DOORS/WINDOWS: overall in good repair

Note: Maintain Gutters & Downspouts annually. Extend Downspouts at least 6-feet away from the house

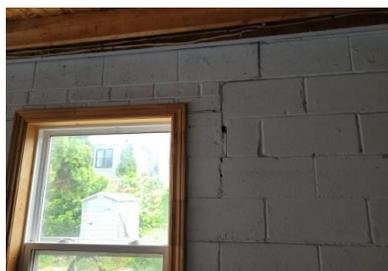
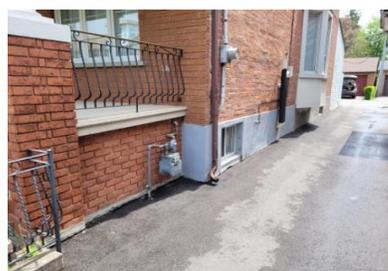
PORCH overall in good repair

DETACHED GARAGE: overall well built, minor settlement

**Walk(s)/Driveway(s): overall in good repair

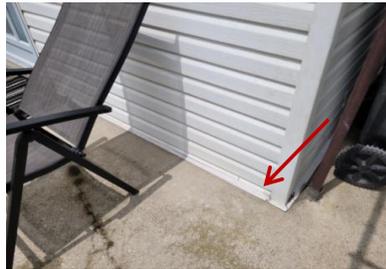
FLOORS: rear extension - framing at/below grade prone to moisture damage, not visible due to finishes, monitor area

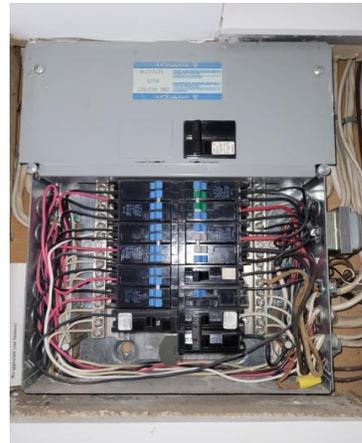
SERVICE PANEL: overall in good repair

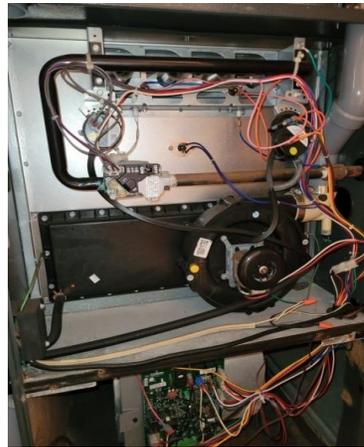
FORCED AIR FURNACE: [service annually](#)

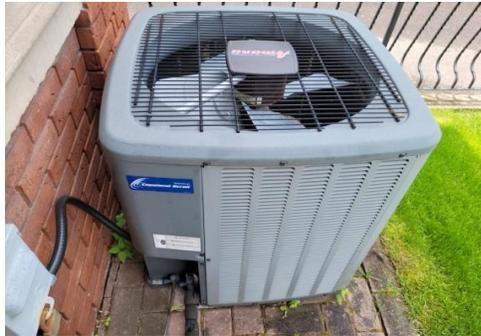
AIR CONDITIONER: [service annually](#)

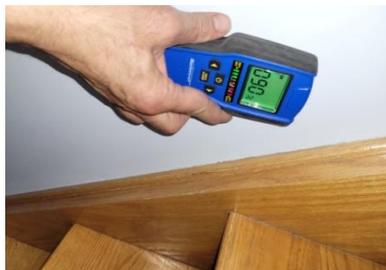
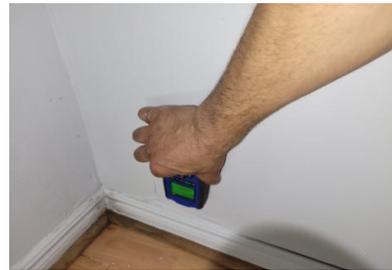
****Basement Leakage:** some dampness noted around rear of basement extension, overall minor, continue to monitor and budget to damp-proof foundation, recommend damp-proofing if renovating basement long term moisture may result in visible or concealed mould growth. Environmental Consultants can assist if this is a concern

1. gutters, downspouts, grading, driveways: ongoing maintenance and repair/see Exterior
2. cracks/form ties on foundation: monitor/repair as required
3. excavation/damp-proofing: monitor basement, consider step 3 as a last resort
