HOME INSPECTION REPORT

178 Madison Ave

Inspection Date: June 29 2015

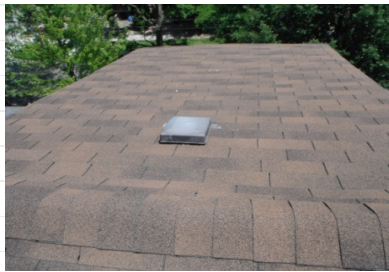
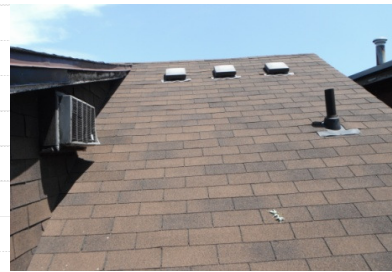
1.0 Roofing:
 Sloped Surface: [overall surface in good repair](#)

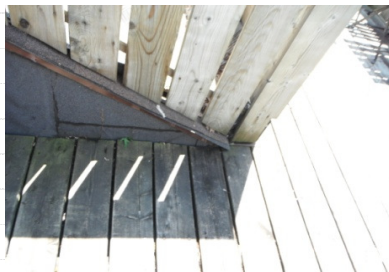
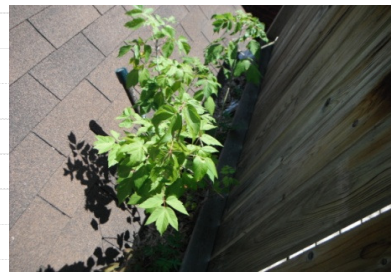
Flat Surface: [mostly not visible due to deck, remove debris, etc. behind deck](#)

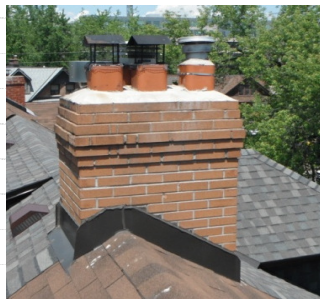
3.0 Chimney(s): [rebuilt and in good repair](#)

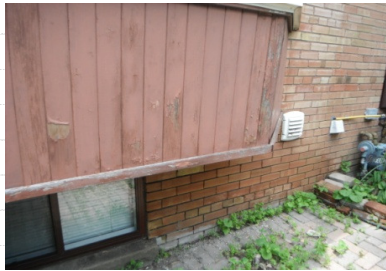
**1.0 Gutters/Downspouts:	require general maintenance
**2.1 Window Well:	at rear - provide window well cover
3.0 WALL SURFACES:	overall in good repair
Wood siding:	requires general repairs and maintenance

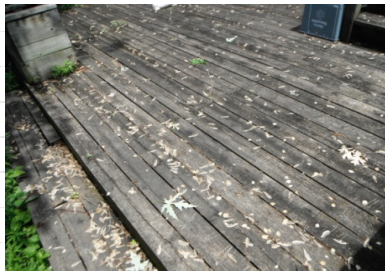
5.0 DECK old, could repair though replacement likely more cost effective

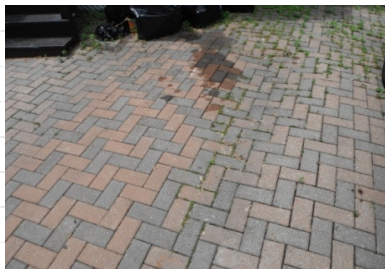
**7.0 Driveway(s): uneven -pavers can be reinstalled and driveway should slope away form house

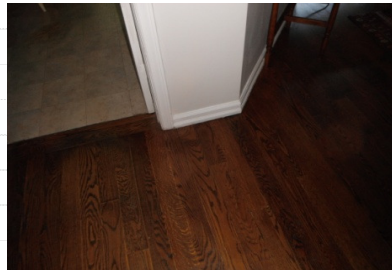
5.0 FLOORS: main level- sagging/sloping around kitchen area, appears that floor framing has been modified with beam and posts, due to drywall and floor finishes limited visibility to determine if properly supported in basement, hover this appears to be an older conduit and no signs of distress observed, should be monitored

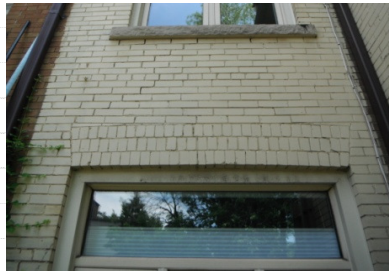
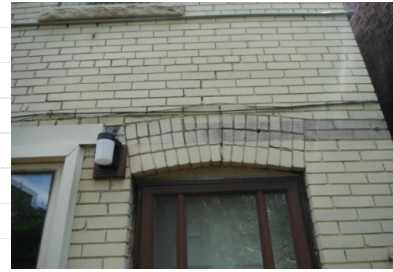
6.0 WALLS:
Masonry Arches: typical settlement cracks and mortar repairs, continue to monitor, repair mortar as required

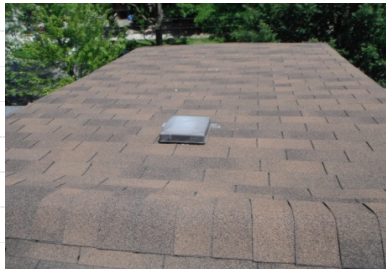
7.0 ROOF: sagging noted at front dormer as observed from on top of roof, overall not unusual

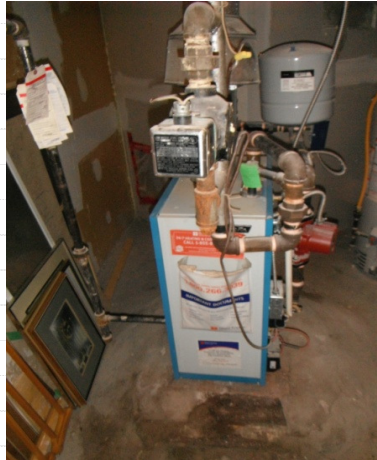
6.0 HOT WATER BOILER: [service annually](#)
[annual CO test mandatory for this type of unit](#)

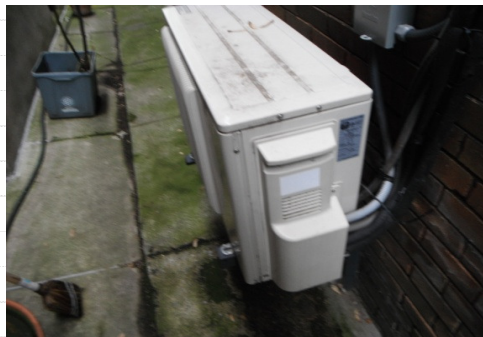
1.0 AIR CONDITIONER: [service annually](#)
