HOME INSPECTION REPORT

18 Captain Rolph Blvd
Markham

Inspection Date: Apr 6 2021

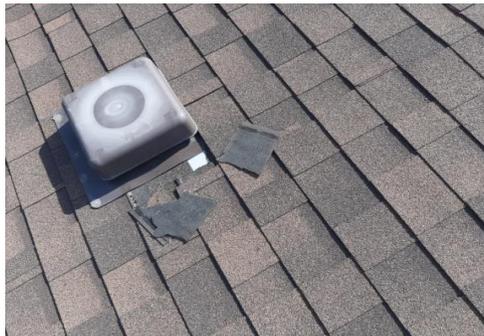
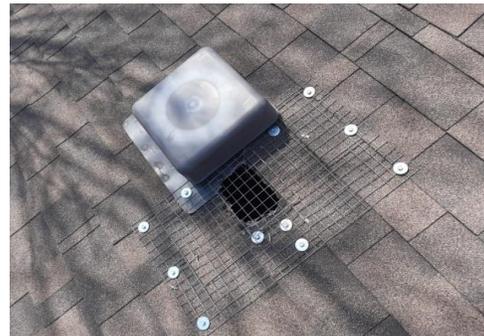
Sloped Surface: [overall surface in good repair](#)
[requires repairs around vents and repair hole](#)

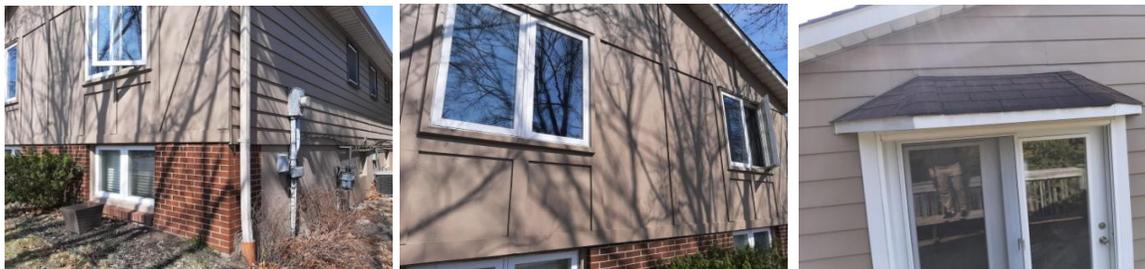
DOORS/WINDOWS: overall in good repair, replace older shingles at rear bay

Wood siding: ongoing maintenance

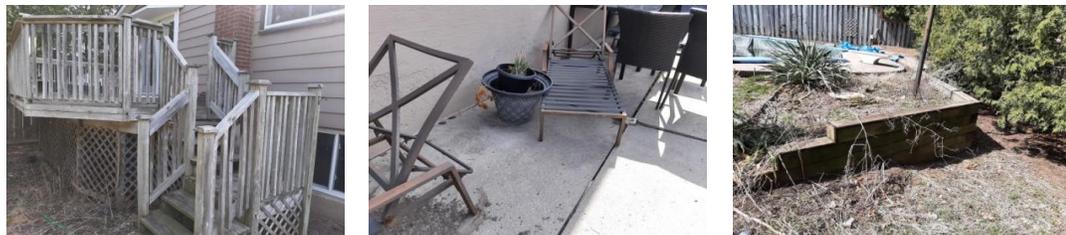
DECK: older, ongoing repairs though likely more cost effective to replace

****Walk(s):** front entrance -requires repairs, trip hazard, backyard - slopes towards house seal gap along wall and budget to repair

RETAINING WALL: monitor/repair as required and budget to replace

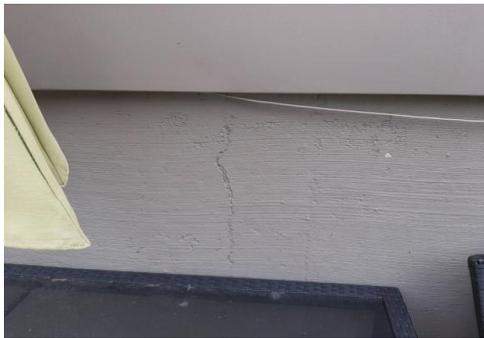
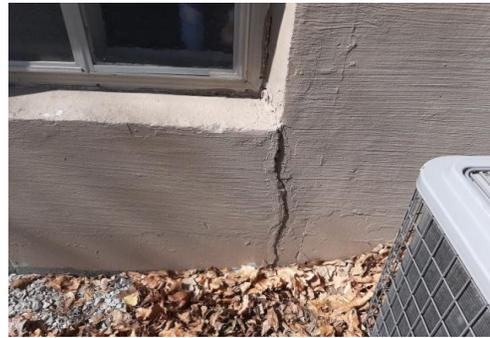
FOUNDATIONS: typical settlement cracks

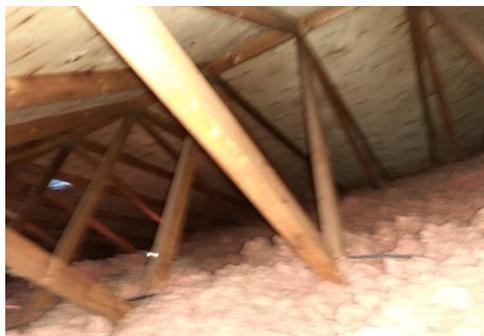
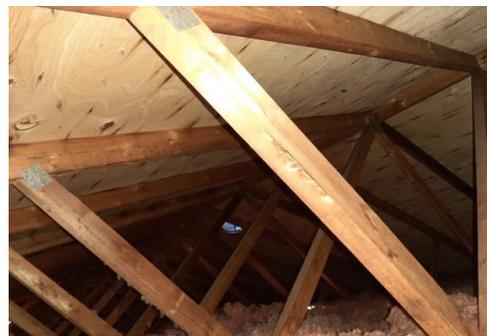
ROOF: overall in good repair
see Roofing Page

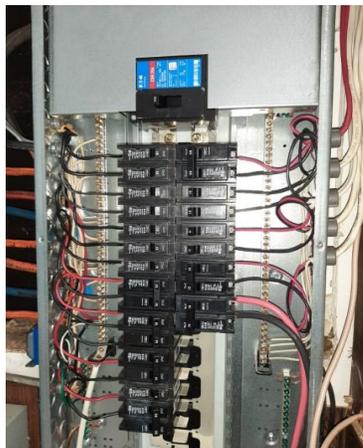
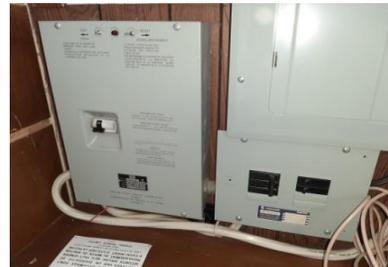
SERVICE PANEL: **overall in good repair**

Auxiliary Panel: **installed for pool - not inspected - inspect with pool**

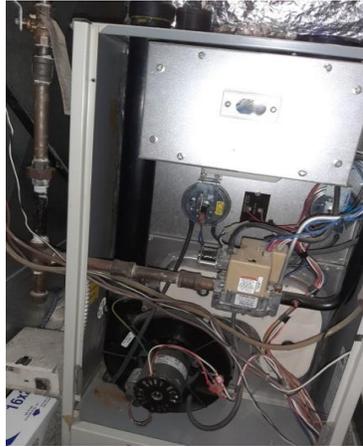
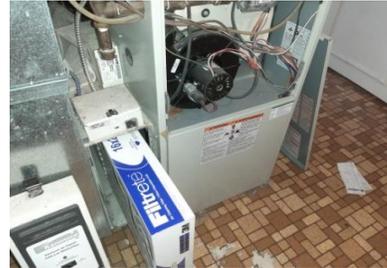
FORCED AIR FURNACE: [continue servicing until replacement becomes necessary](#)

Electronic Filter: [not in use - disconnect power](#)

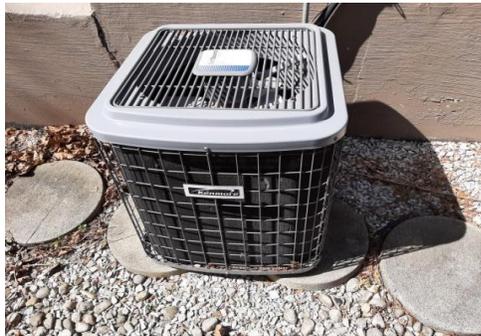
AIR CONDITIONER: **not tested: should be serviced before using old unit, continue servicing until replacement becomes necessary**

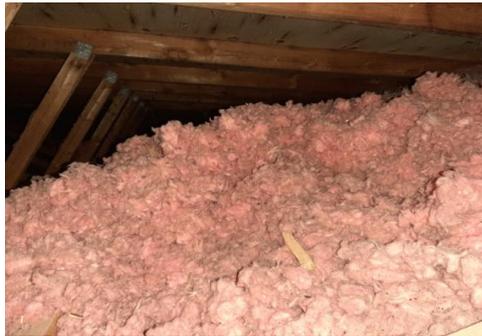
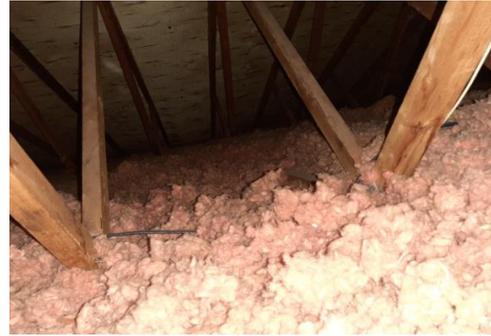
ROOF SPACE: insulation and ventilation is adequate

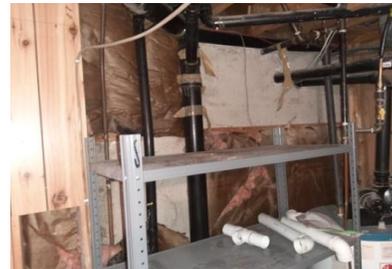
Basement Walls: furnace room: general repairs
