HOME INSPECTION REPORT

20 Beaconsfield Ave

Toronto

Inspection Date: June 27 2014

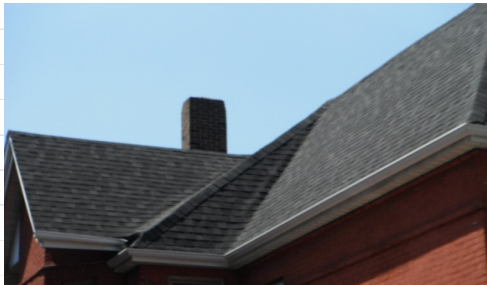
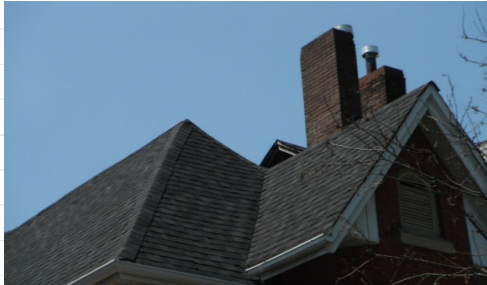
1.0 Roofing:	Sloped Surface: overall surface in good repair

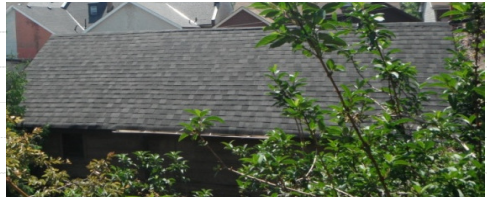
Garage: overall surface in good repair

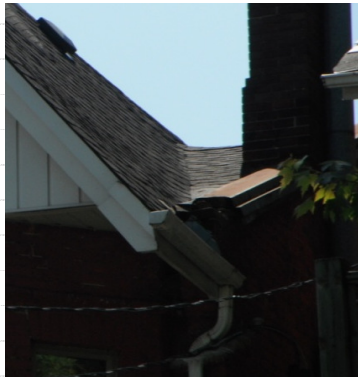
Vulnerable Areas: at north east valley and parapet wall

Note: Recommend Annual Maintenance Contract for Roof Surface, Flashing Details and Chimney(s)

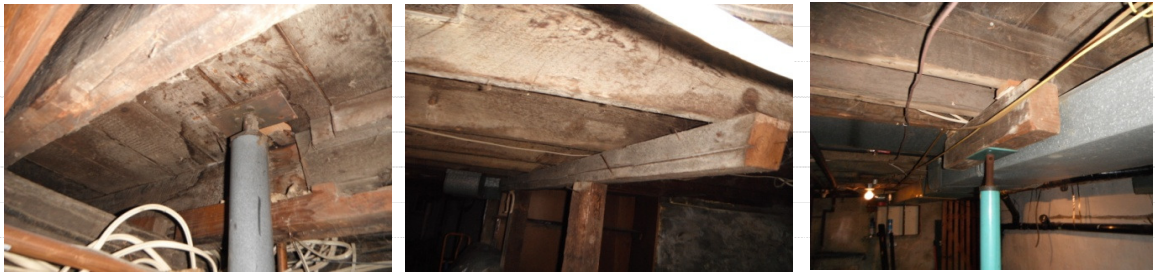
5.0 FLOORS: basement: has been shored up in some areas of basement, these are older repairs and will require improvements if renovating basement

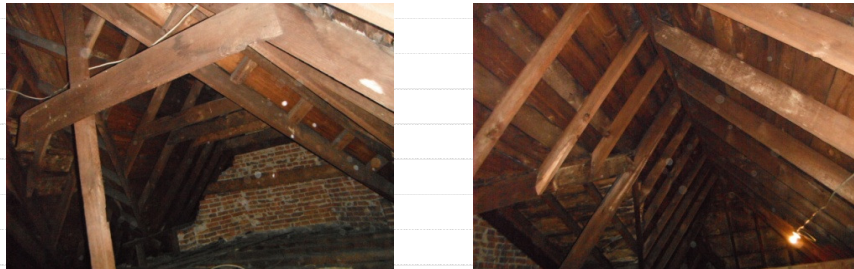
7.0 ROOF: overall in good repair

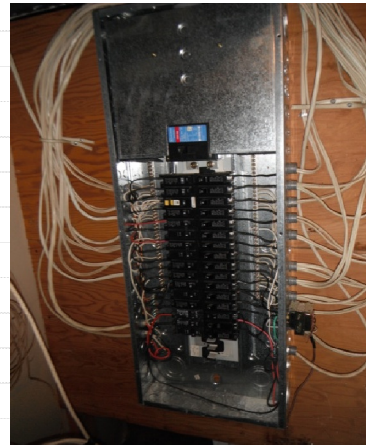
3.0 SERVICE PANEL: overall in good repair

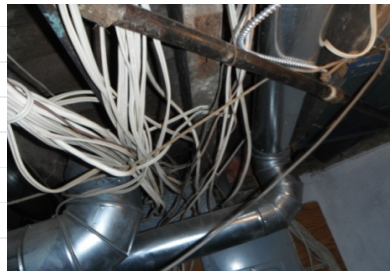
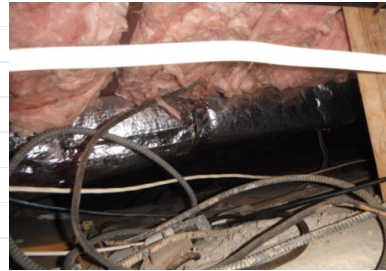
loose, somewhat 'messy' installation in basement/crawlspace and roof space, general 'clean-up' and repairs required in some areas

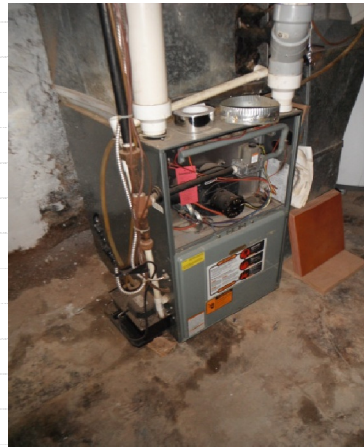
5.0 FORCED AIR FURNACE: [service annually](#)

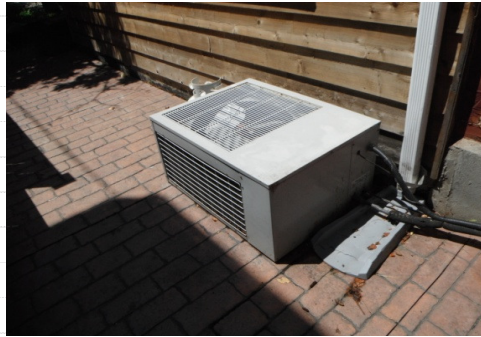
1.0 AIR CONDITIONER: [old unit, continue servicing until replacement becomes necessary](#)

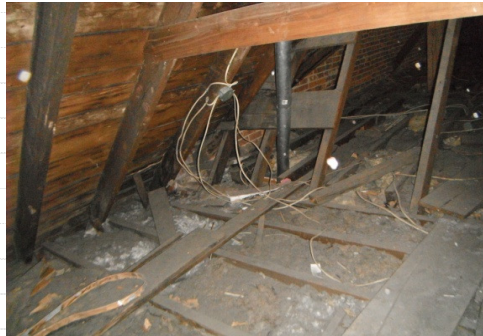
3.0 ROOF SPACE: upgrading insulation will improve comfort and efficiency

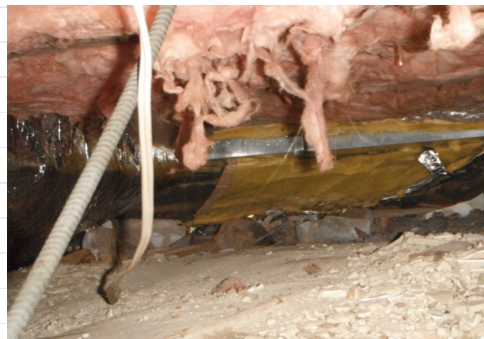
Crawlspace Floor: falling/damaged in some areas, missing around some ducts, also should insulate around water supply pipes to avoid freezing, install moisture barrier on open ground to minimize moisture

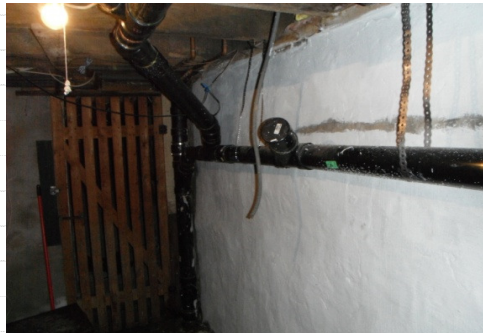
Piping: drain pipe directed to rear stack - typically should be directed towards front of house towards main sewer, not critical - improve if renovating basement
