# HOME INSPECTION REPORT

2249 Bostock Cres

Toronto

Inspection Date: Aug 31 2021

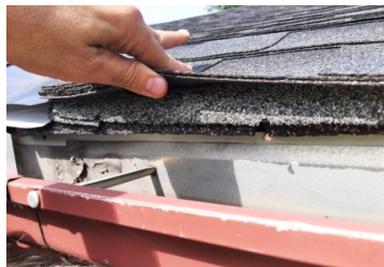
Comments: [older roof shingles were not removed which might reduce life expectancy of newer shingles](#)

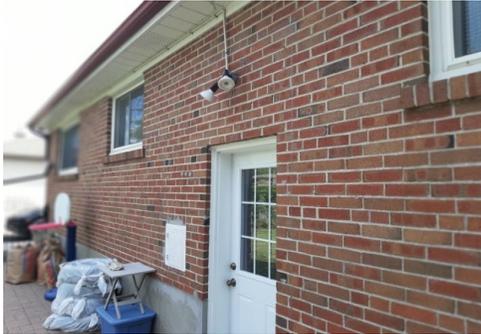
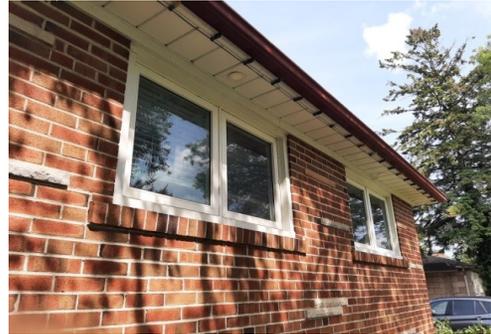
WALL SURFACES: overall in good repair  
DOORS/WINDOWS: overall in good repair

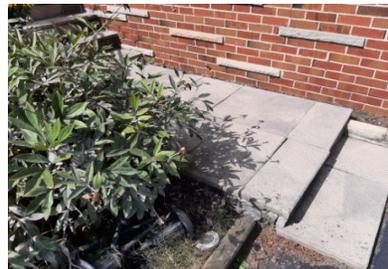
\*\*Walk(s): repair loose paver

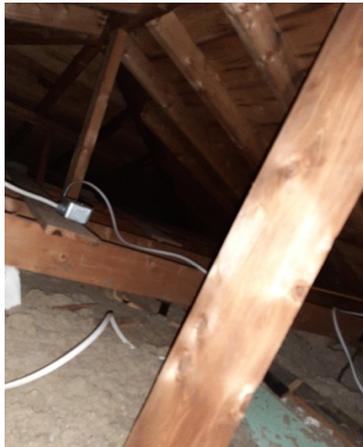
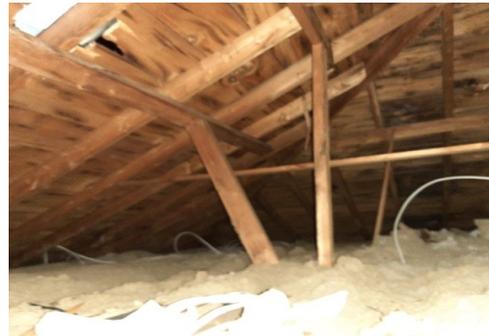
ROOF: overall in good repair

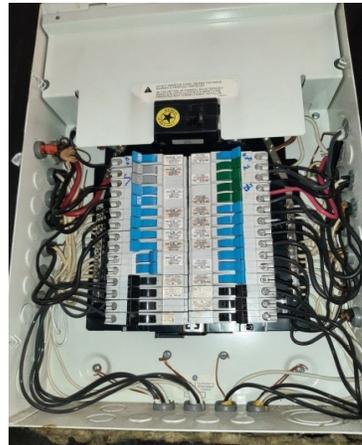
SERVICE PANEL: overall in good repair

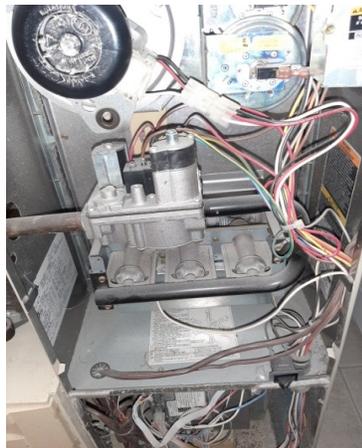
FORCED AIR FURNACE: [continue servicing until replacement becomes necessary](#)

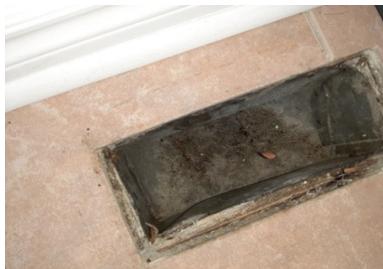
Registers: [insulation around some registers may contain asbestos](#)  
[encapsulating the insulation is often the best approach](#)  
[Environmental Consultants can assist if this is a concern](#)

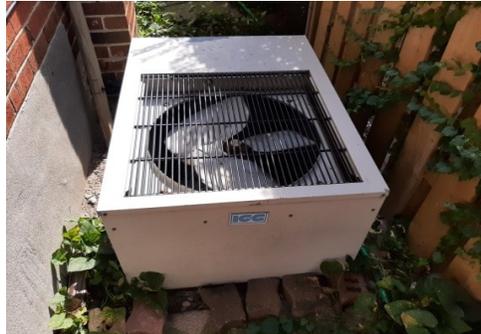
AIR CONDITIONER: **old unit, continue servicing until replacement becomes necessary**

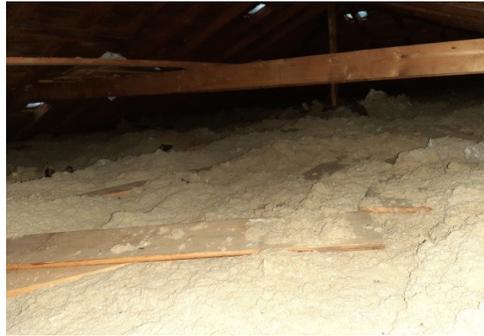
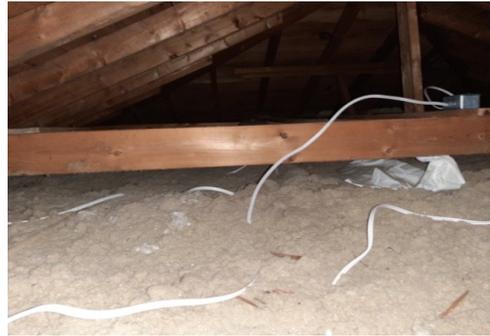
ROOF SPACE: insulation has been upgraded which will improve comfort and efficiency

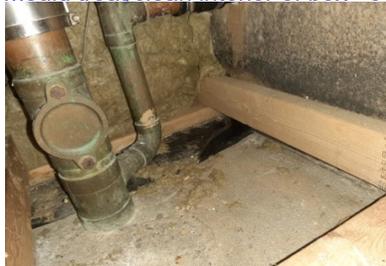
Comments: basement: boxed in pipes causing mould - remove cover, mould treat/clean interior of box - overall minor
