HOME INSPECTION REPORT

3397 Eglinton Ave W
Mississauga

Prepared by: Bob Papadopoulos P.Eng., RHI *

Inspection Date: Dec 29 2014

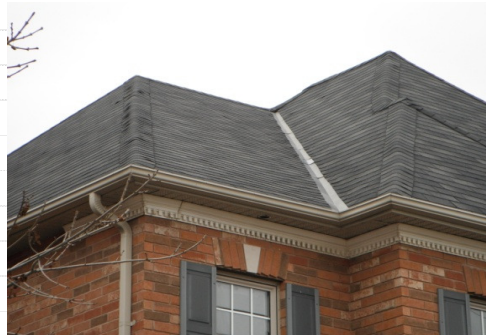
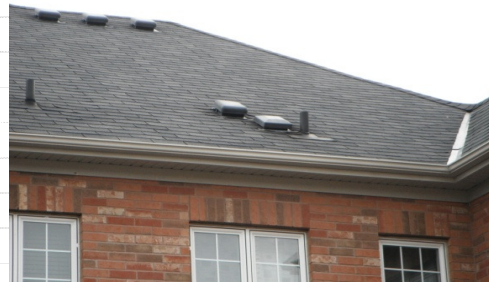
1.0 Roofing:	Sloped Surface: overall in good repair, appears to have had prior leaking at front though present owners report no leaking for 5-yrs, area should be monitored, providing caulking along valley edges should be considered to minimize risk
--------------	---

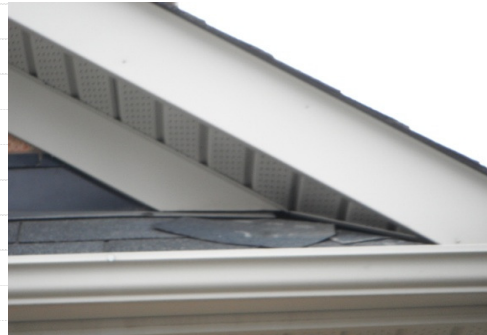
loose shingle at rear garage

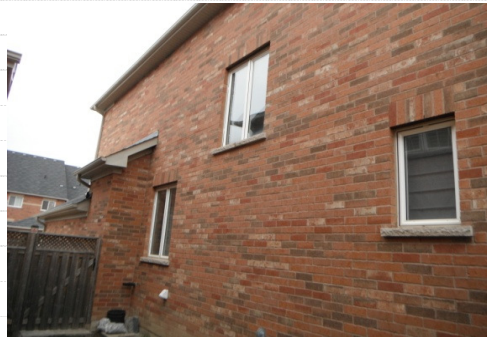
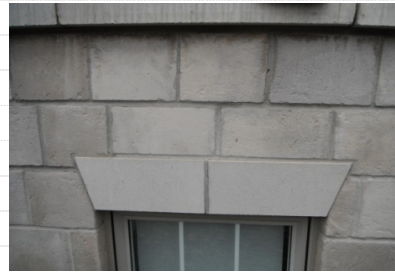
3.0 WALL SURFACES: overall in good repair, minor hairline cracks at front

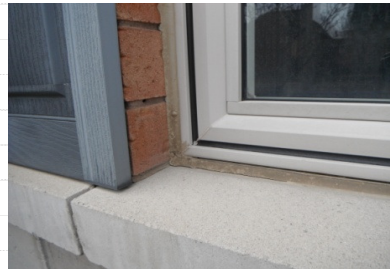
4.0 DOORS/WINDOWS: minor caulking repairs required at front

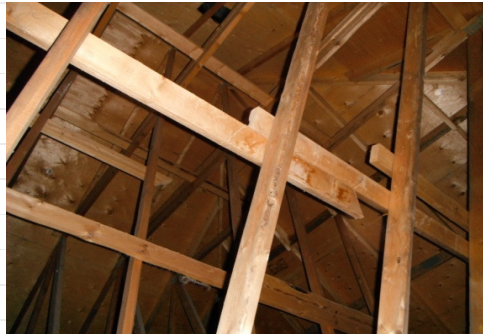
7.0 ROOF: [overall in good repair](#)

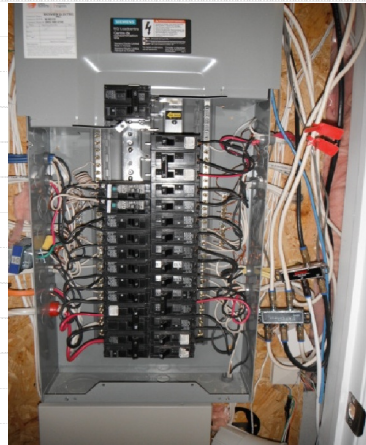
3.0 SERVICE PANEL: overall in good repair

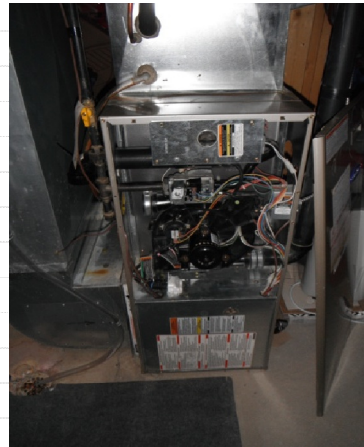
5.0 FORCED AIR FURNACE: service annually

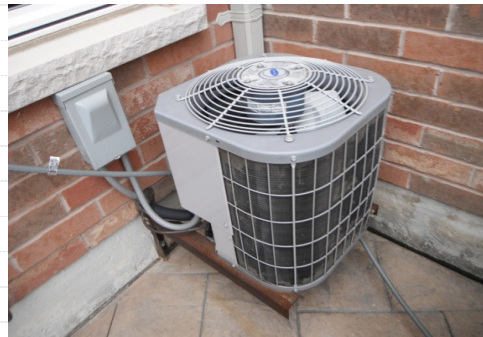
1.0 AIR CONDITIONER: not tested: should be serviced before using

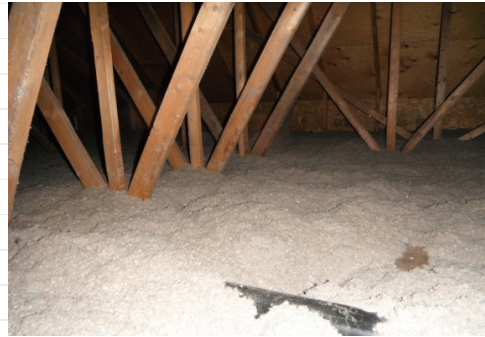
3.0 ROOF SPACE: insulation and ventilation is adequate

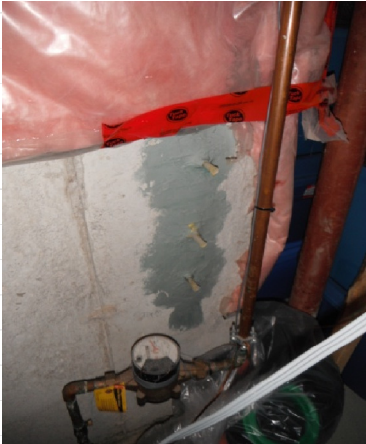
Ref#*	Observations/Recommendations
	1.0 Floors/2.0 Walls/3.0 Ceilings: overall in good repair 4/5.0 Trim/Cabinets/Counters: overall in good repair
	**10.0 Basement Leakage: the foundation has been damp-proofed to minimize risk of basement leaking presently no concerns, see Steps below prior crack repair noted in furnace room
