# HOME INSPECTION REPORT

46 Seaforth Ave

Prepared by: Bob Papadopoulos P.Eng., RHI \*

Inspection Date: Feb 21 2017

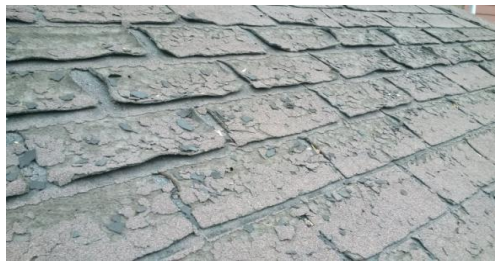
Porch(s): old shingles require replacement

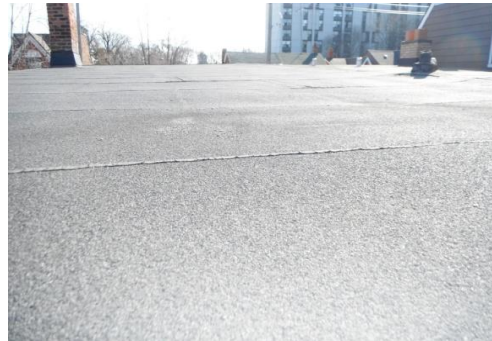
Flat Surface: newer surface in good repair

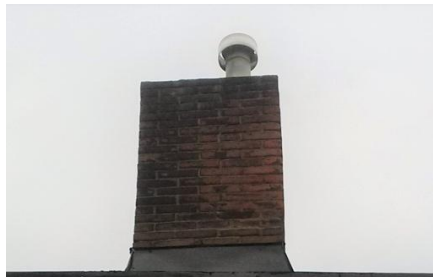
Chimney(s): some leaning observed - monitor and rebuild if required

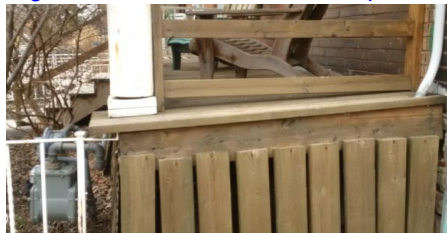
**PORCH** sagging floor, column requires proper support, overall repairs required though it might be more cost effective to replace, rails require spindles

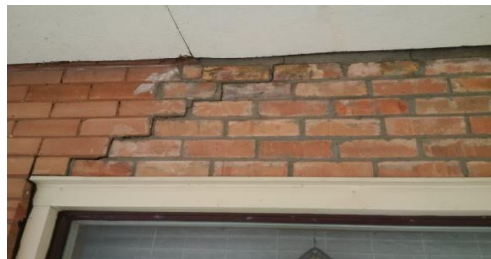
Metal Lintel: front main level window: some sagging and cracks in brick above, lintel is possibly undersized - should be repaired/replaced though overall this is an older condition

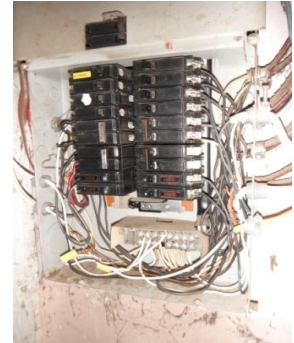
**Observations/Recommendations**SERVICE PANEL: **crowded, double taps, install sub-panel if required**
