HOME INSPECTION REPORT

55 Cameron Ave

Toronto

Inspection Date: [May 22 2026](#)

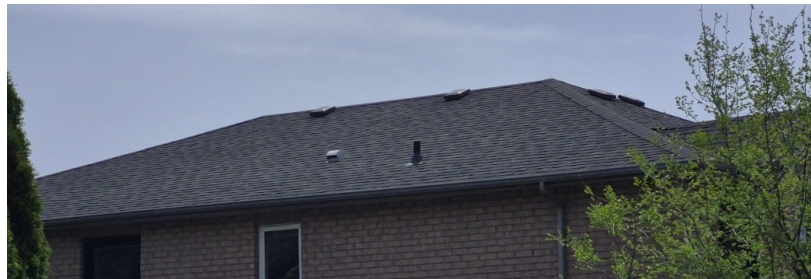
Sloped Surface: [overall surface in good repair](#)
[south side not accessible](#)

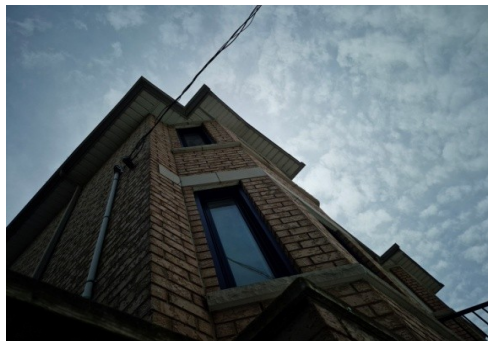
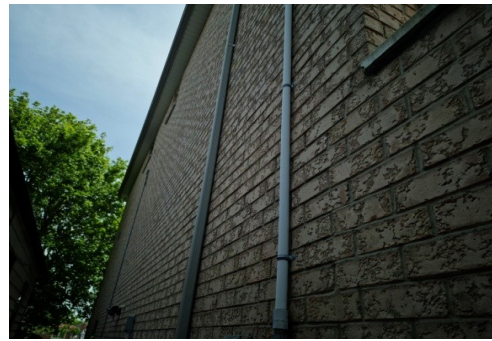
WALL SURFACES: overall in good repair
DOORS/WINDOWS: overall in good repair

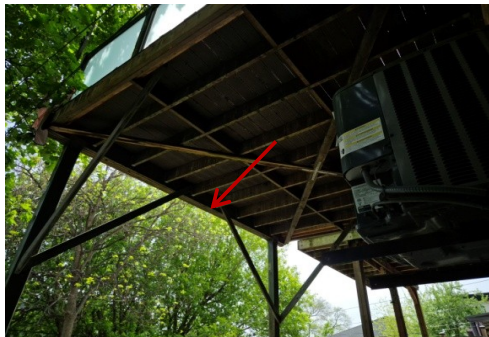
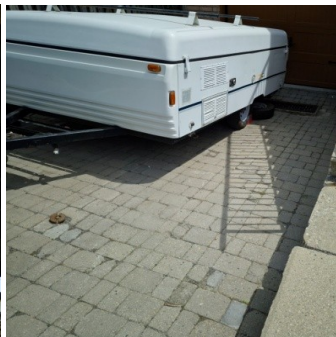
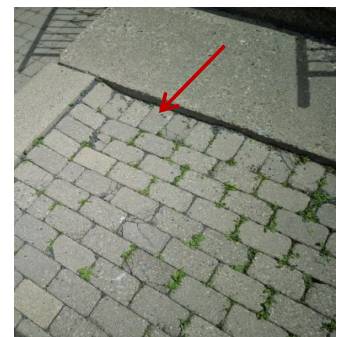
DECK columns: minor splitting: monitor, consider installing central column to improve stability, floor boards: some warped- replace as required
 **Driveway(s): service/clean drain, some pavers damaged - replace as required
 **Walk(s): minor settlement, reset pavers
 ATTACHED GARAGE: service/clean drain, interior door requires auto closer

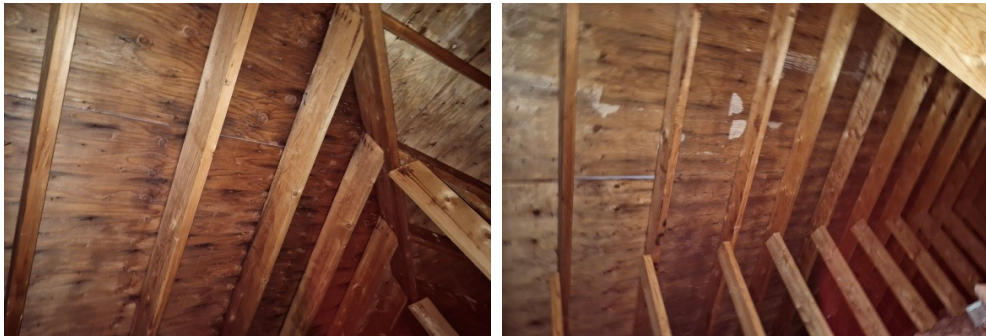
ROOF: overall in good repair

Roof Sheathing: some staining at underside typical

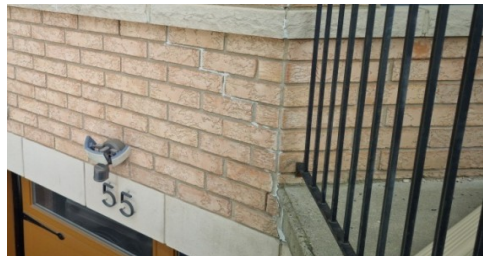
Brick Veneer: front: minor/prior settlement crack/repaired

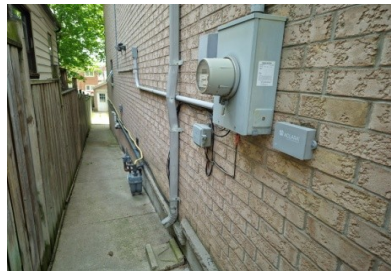
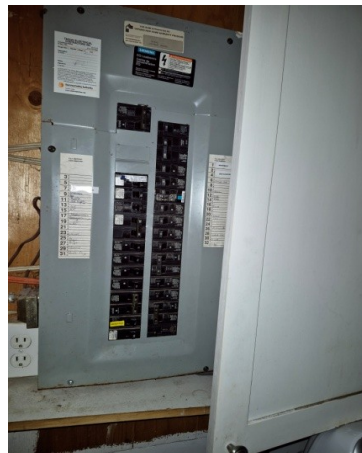
SERVICE ENTRANCE: **overall in good repair**
 SERVICE PANEL: **overall in good repair**

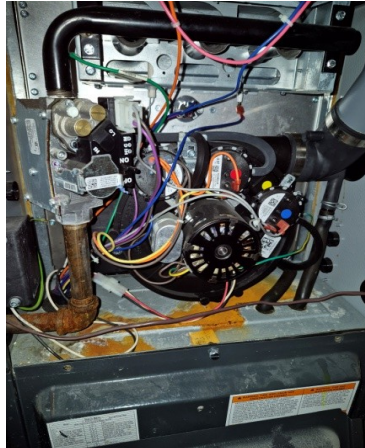
FORCED AIR FURNACE: [service annually](#)
[some rusting noted, maintenance to condensate drains, etc. next service](#)
Filter: [replace 1-per-3 months](#)

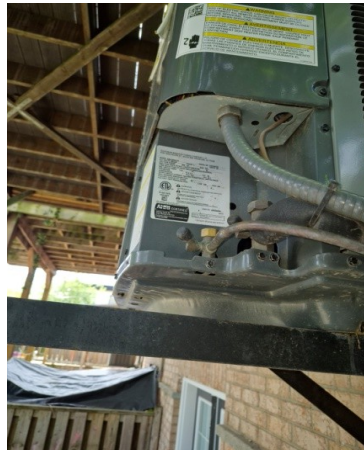
AIR CONDITIONER: not tested: should be serviced before using

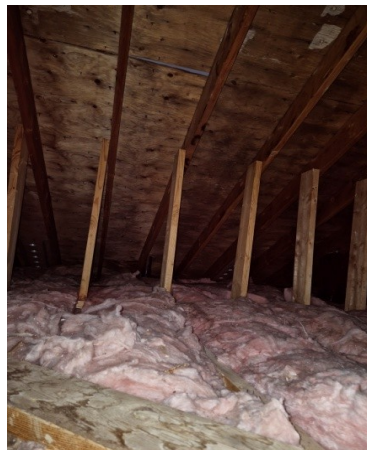
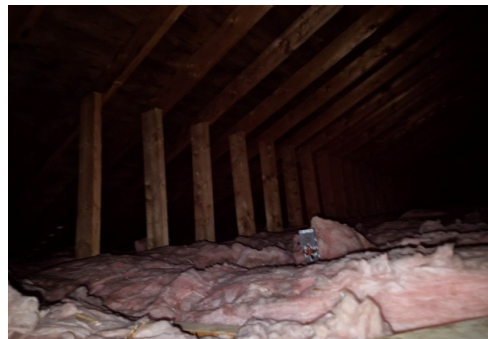
ROOF SPACE: insulation and ventilation is adequate
