HOME INSPECTION REPORT

594 Indian Grove

Prepared by: Bob Papadopoulos P.Eng., RHI *

Inspection Date: Aug 25 2020

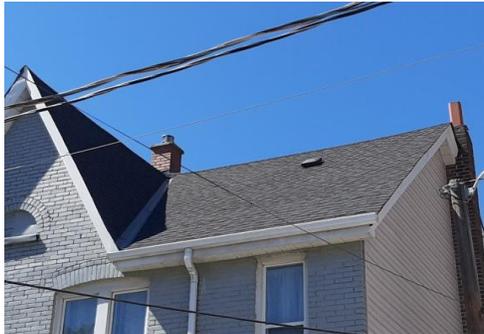
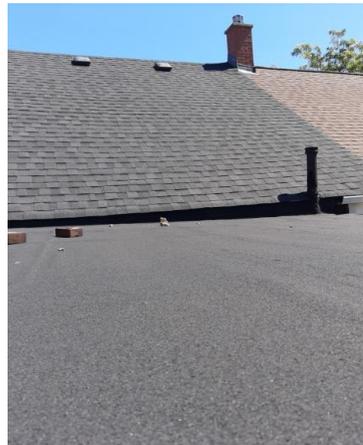
Sloped Surface: [overall surface in good repair](#)
 Flat Surface: [overall surface in good repair](#)

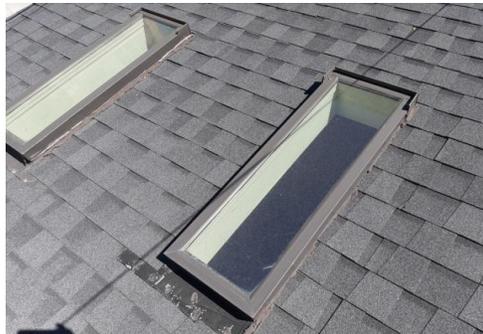
Skylight(s): [overall in good repair](#)

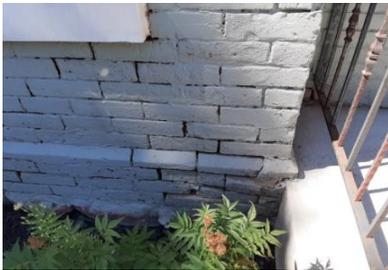
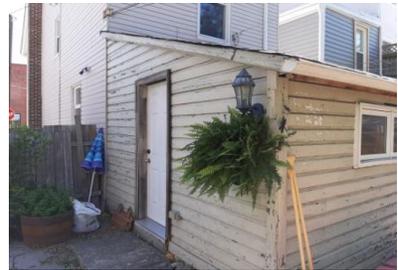
Wood siding: requires general repairs and maintenance

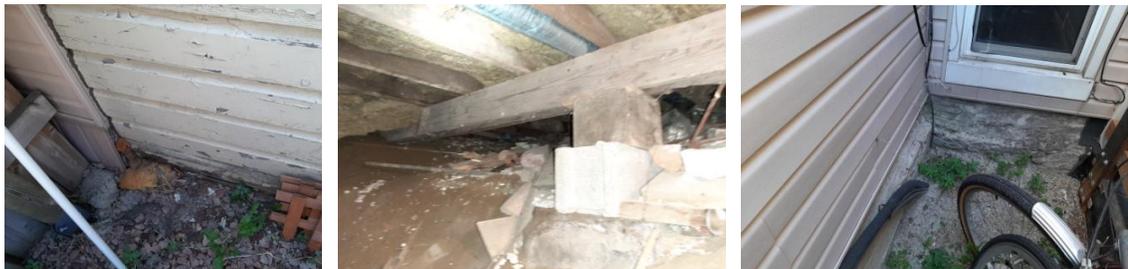
FLOORS: west crawlspace: wood framing is at or below grade which can lead to rot, although this is an older condition recommend budgeting to excavate around exterior perimeter for further evaluation and repair of framing, also install concrete sill with damp-proofing, it was noted that concrete has been installed around south portion to minimize wood soil contact

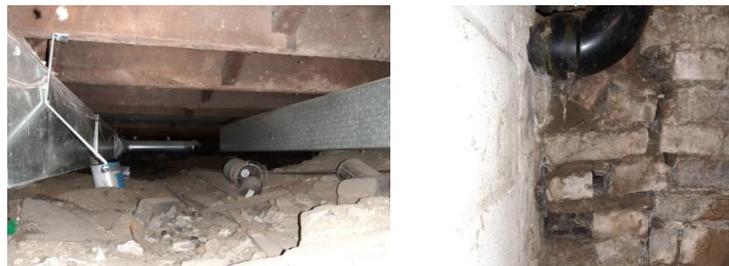
FOUNDATIONS: east crawlspace: typical mortar deterioration, older condition, budget for repairs

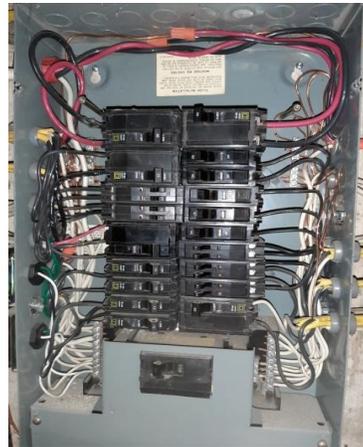
SERVICE PANEL: overall in good repair

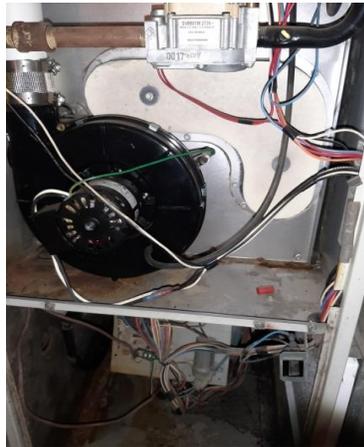
FORCED AIR FURNACE: [continue servicing until replacement becomes necessary](#)

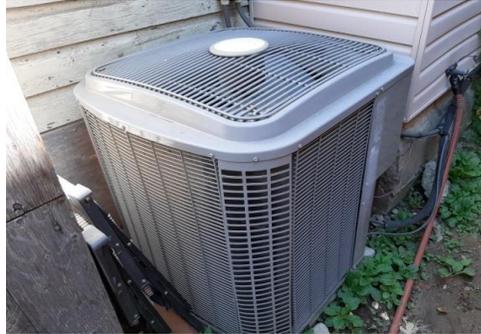
AIR CONDITIONER: **aging unit, continue servicing until replacement becomes necessary**

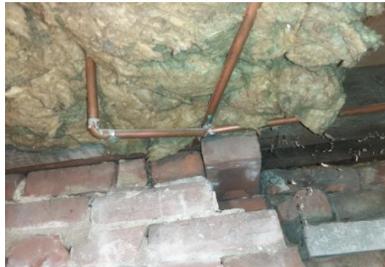
Pipes: Unheated Areas: [crawlspace: insulate supply pipes to minimize risk of freezing and/or install heating cable to pipes](#)

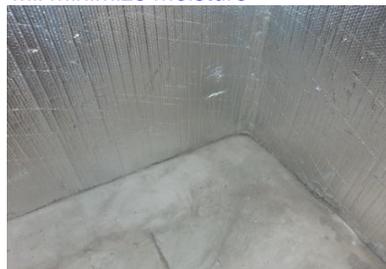
**Crawlspace Leakage: typical efflorescence, staining and dampness for older foundation
see steps below

**Basement Leakage: it appears the basement has been damp-proofed which will minimize moisture

1. gutters, downspouts, grading, driveways: ongoing maintenance and repair/see Exterior
2. cracks/form ties on foundation: monitor/repair as required
3. excavation/damp-proofing: monitor basement, consider step 3 as a last resort
