# HOME INSPECTION REPORT

6245 Prarie Circle  
Mississauga

Inspection Date: April 23 2015

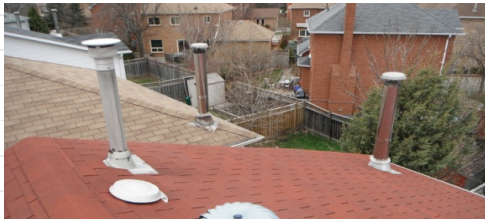
3.0 Chimney(s): overall in good repair, one rusting unit though typical

Note: Recommend Annual Maintenance Contract for Roof Surface, Flashing Details and Chimney(s)

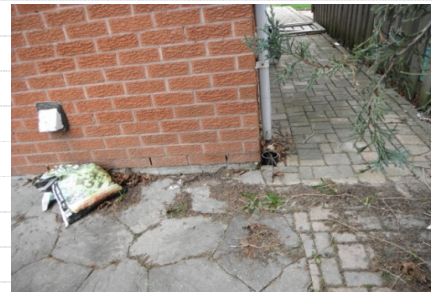
\*\*2.0 Lot Grading:

\*\*North Grading: re-grade and slope way from house

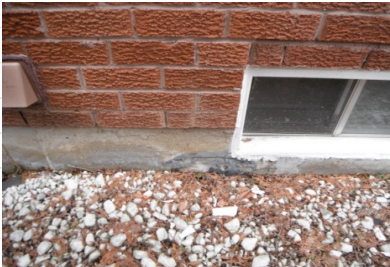
Description				
2.0 Configuration: Basement:	4.0 Foundations: Poured Concrete	5.0 Floor : Wood Joists	6.0 Walls : Wood Frame(Brick Veneer)	7.0 Roof/Ceiling Framing: Wood Trusses
Limitations				
Restricted Access to: Wall Space		Foundation Wall Not Visible: <u>90</u> % Roof Space Inspected From Access Hatch		
Observations/Recommendations				
<div> <div>4.0 FOUNDATIONS: typical settlement cracks</div>

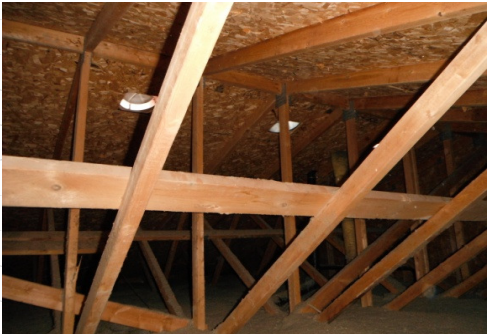
</div>				
<div> <div>7.0 ROOF: overall in good repair</div>

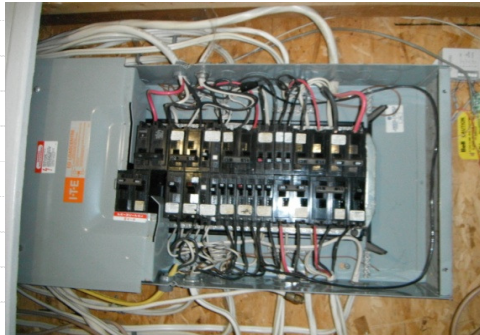
3.0 SERVICE PANEL: overall in good repair

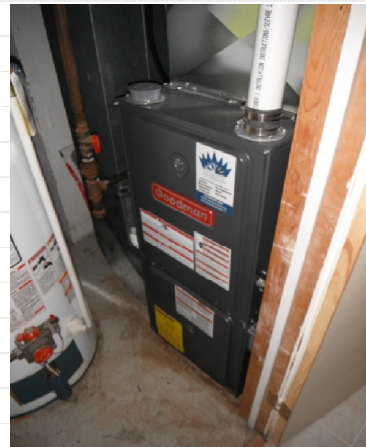
5.0 FORCED AIR FURNACE: service annually

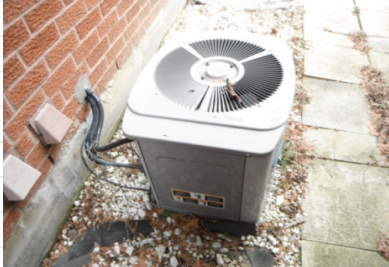
Description			
1.0 Description:	1.4 Cooling Capacity:	1.5 Approx. Age:	Typical Life Expectancy:
1.0 Air Conditioner (air-cooled):	24 x1,000 BTU/hr	24 yrs. old	15 yrs.
Limitations			Cooling Performance
Cannot Test With Low Outdoor Temp			Supply Temp F:
			Return Temp F:
Ref#*	Observations/Recommendations		
	1.0 AIR CONDITIONER: not tested: should be serviced before using

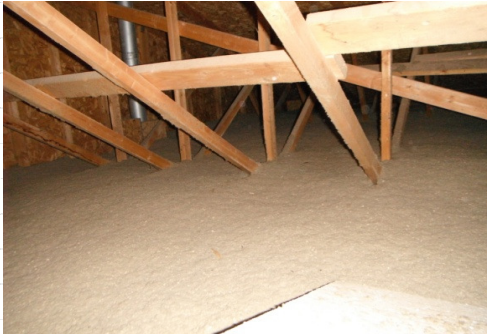
Ref#*	Observations/Recommendations
	<p>3.0 ROOF SPACE: insulation and ventilation is adequate</p>
