# HOME INSPECTION REPORT

723 St Clarens Ave  
Toronto

Inspection Date: March 23 2018

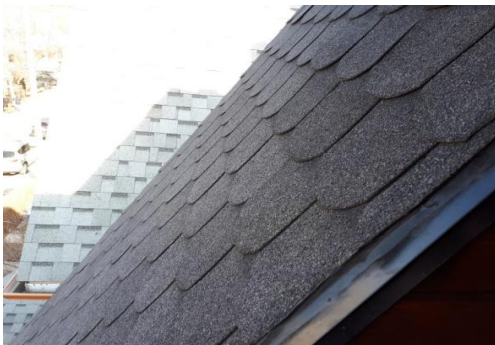
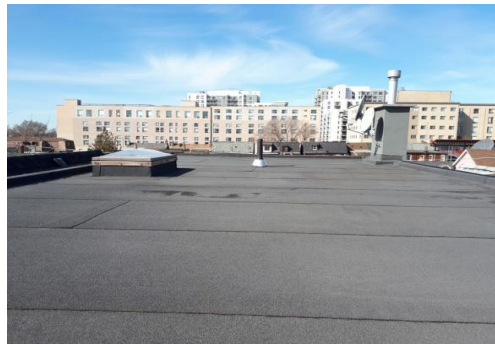
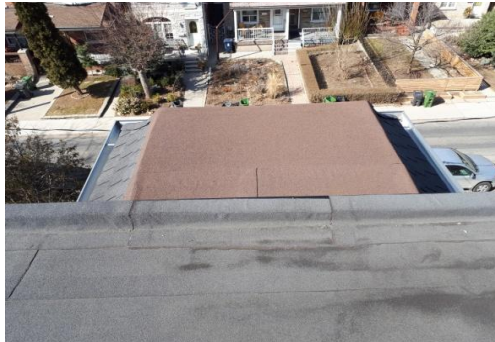
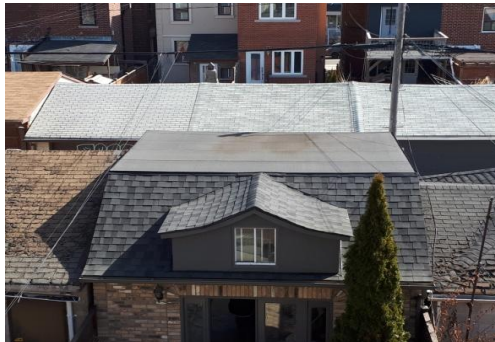
Sloped Surface: [surfaces in good repair](#)

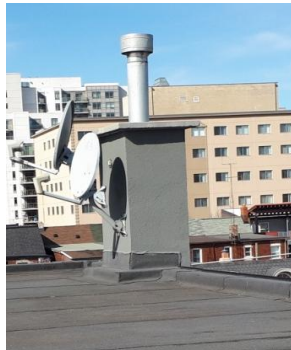
Chimney(s): [rebuilt and in good repair](#)

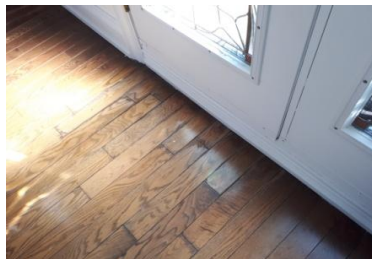
Comments: 3rd level rear door: staining observed on floor, area prone to water due to low threshold- monitor and repair if required

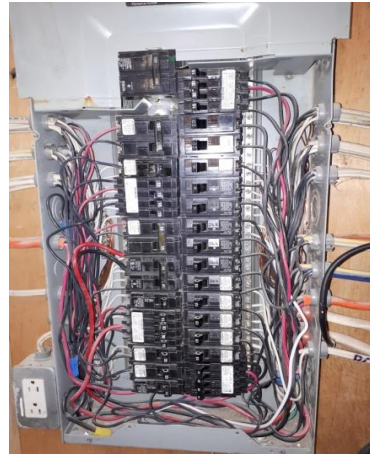
SERVICE PANEL: **overall in good repair**

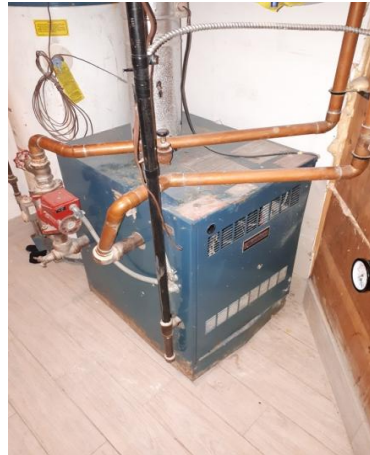
HOT WATER BOILER: [requires servicing, front cabinet damage](#)  
[continue servicing until replacement becomes necessary](#)  
[annual CO test mandatory for this type of unit](#)

[boiler room requires opening for combustion air: recommend opening through wall to exterior](#)

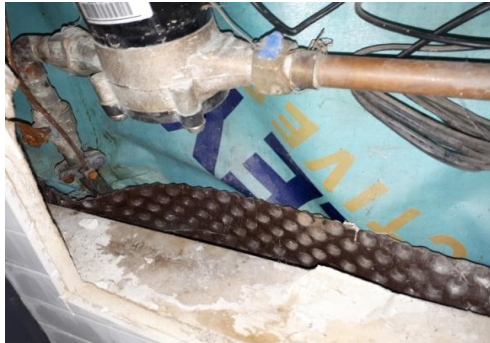
\*\*Basement Leakage: the basement has been damp-proofed which will minimize moisture

\*\* Steps recommended in order to minimize basement leakage

1. gutters, downspouts, grading, driveways: ongoing maintenance and repair/see Exterior
