# HOME INSPECTION REPORT

79 Beaconsfield Ave  
Toronto

Inspection Date: June 16 2020

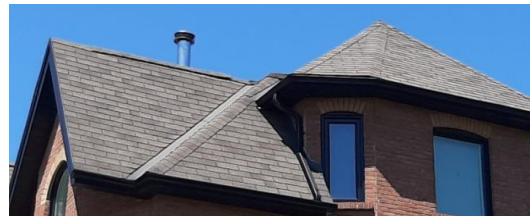
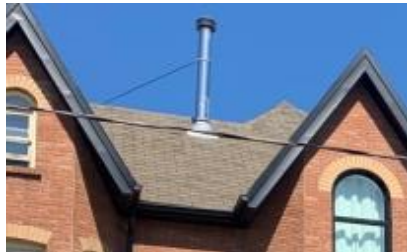
Sloped Surface: [curling, aging surface, budget to replace within 5-yrs](#)  
[front overhang more worn shingles - replace as required](#)

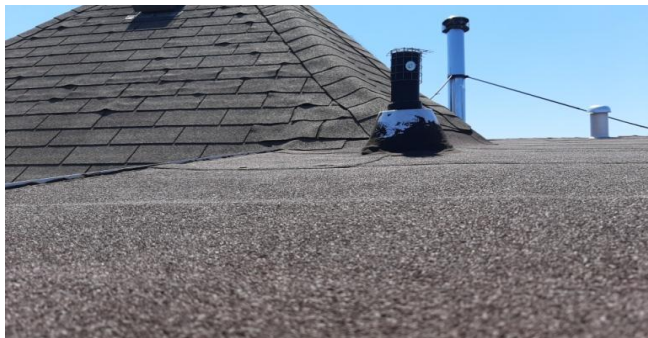
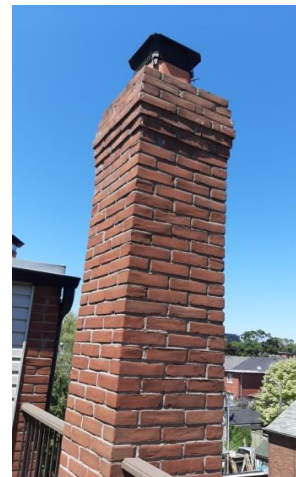
Flat Surface: [overall surface in good repair](#)  
 2nd Flat: [3rd level: not visible due to deck](#)  
 Chimney(s): [in good repair](#)

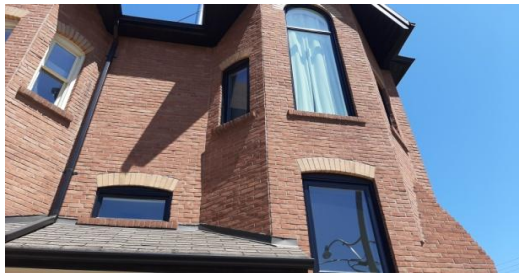
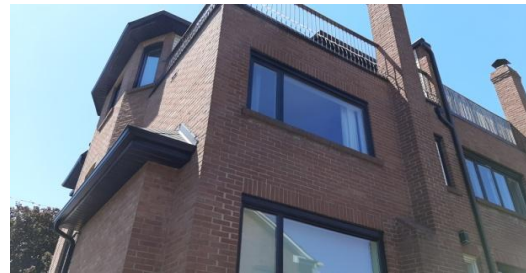
\*\*Gutters/Downspouts: newly installed in good repair  
Soffit & Fascia: newly installed in good repair

WALL SURFACES: overall in good repair  
DOORS/WINDOWS: newly installed in good repair

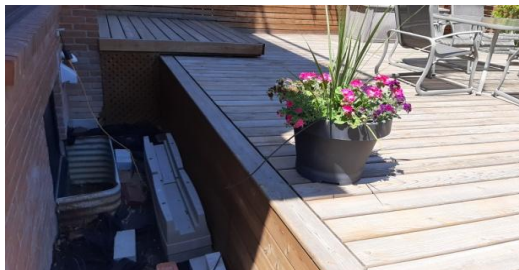
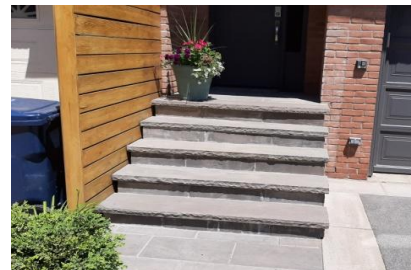
DECK(s): overall in good repair, recommend safety rails at edges and steps  
PORCH overall in good repair, recommend safety rails to steps

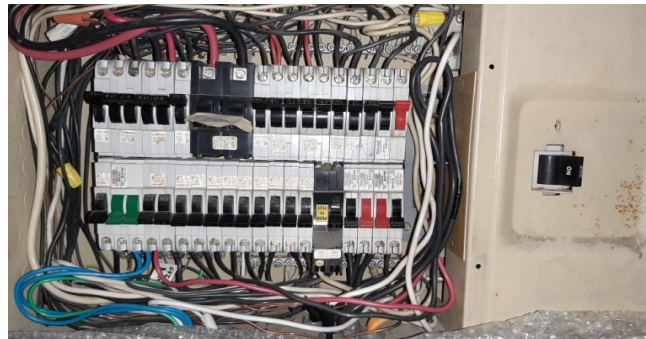
SERVICE PANEL: **crowded though overall in good repair**

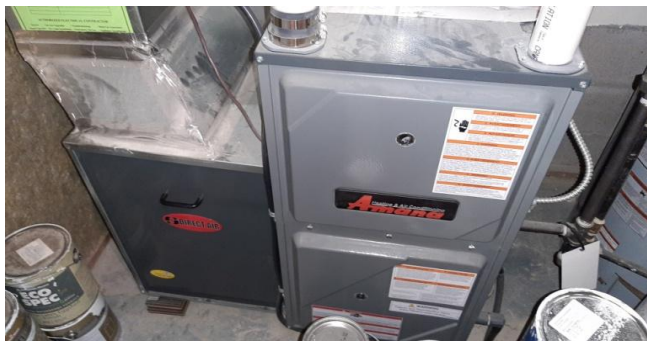
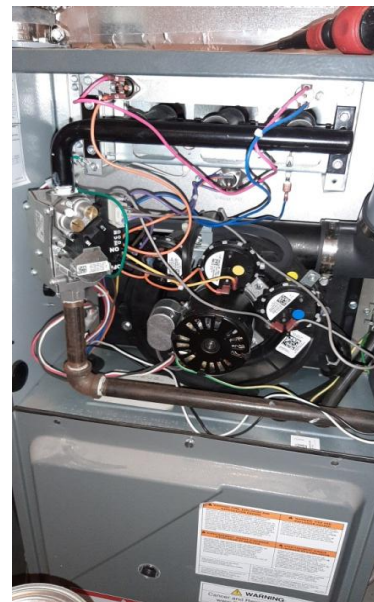
FORCED AIR FURNACE: [service annually](#)  
 Filter: [replace 1-per-6 to 12 months](#)

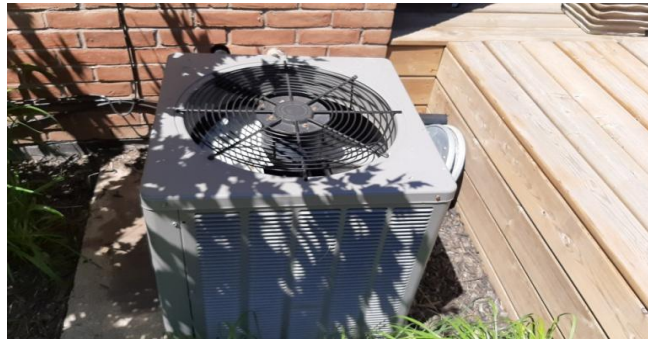
AIR CONDITIONER: aging unit, continue servicing until replacement becomes necessary

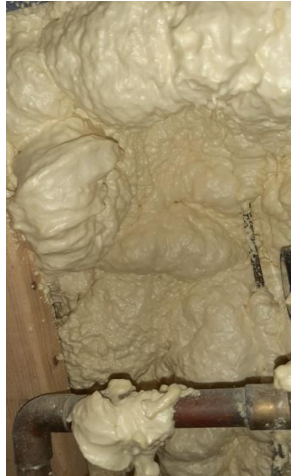
Basement Walls: spray foamed walls which is above average
