HOME INSPECTION REPORT

79 Beaconsfield Ave
Toronto

Prepared by: Bob Papadopoulos P.Eng., RHI *

Inspection Date: June 16 2020

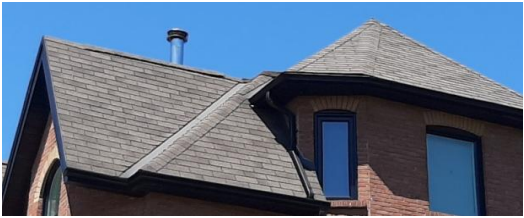
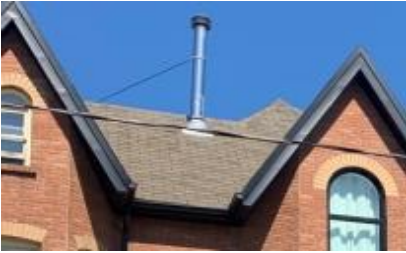
June 16 2020	
Description			
Roofing Material:	Location:	Leakage Probability:	Chimney(s) Type:
Asphalt Shingles:	Slope:	Medium	Brick:
Modified Bitumen:	Flat:	Low	Metal:
Modified Bitumen:	2nd Flat:	?	
Limitations			
Roof Inspected By:	Access Limited By:	Chimney Access Limited By:	
Binoculars	Deck	Height	
From Edge	Height		
Observations/Recommendations			
<p>Sloped Surface: curling, aging surface, budget to replace within 5-yr front overhang more worn shingles - replace as required</p> <div style="display: flex; justify-content: space-around;">

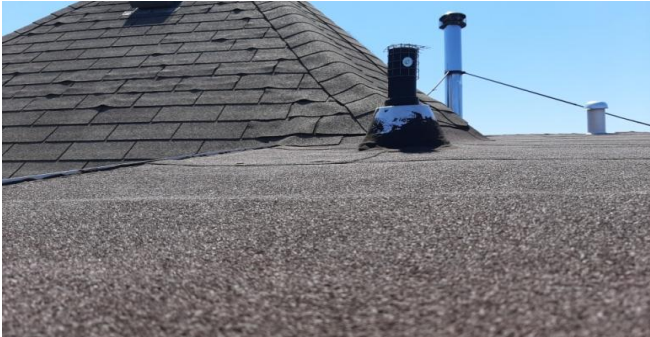
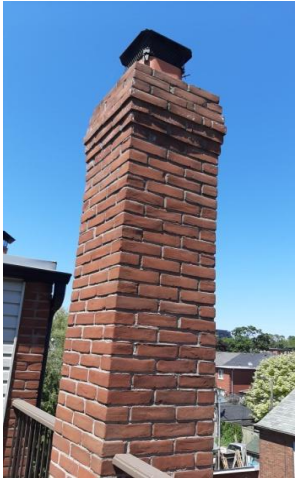
</div> <p>Flat Surface: overall surface in good repair 2nd Flat: 3rd level: not visible due to deck Chimney(s): in good repair</p> <div style="display: flex; justify-content: space-around;">

<p>Note: Recommend Annual Maintenance Contract for Roof Surface, Flashing Details and Chimney(s)</p>

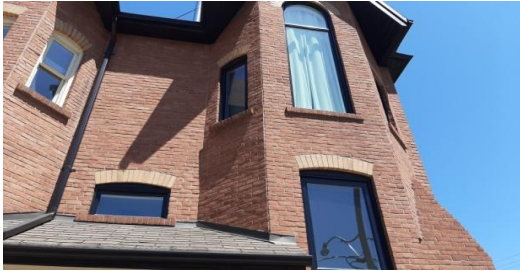
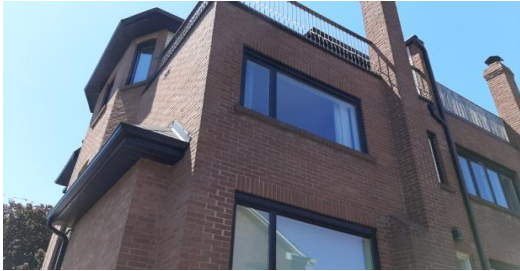
</div> </div>	
		June 16 2020	
Description			
Gutters & Downspouts: Aluminum:	Downspout(s) Discharge: Various Above Grade	Lot Topography: Away From House	Walls & Wall Structures: Brick Vinyl Siding
Limitations			
Exterior Inspection from Ground Level		Storage in Garage	
Restricted Access Under Deck(s)			
Observations/Recommendations			
<p>**Gutters/Downspouts: newly installed in good repair</p> <p>Soffit & Facia: newly installed in good repair</p> <p>WALL SURFACES: overall in good repair</p> <p>DOORS/WINDOWS: newly installed in good repair</p> <div>

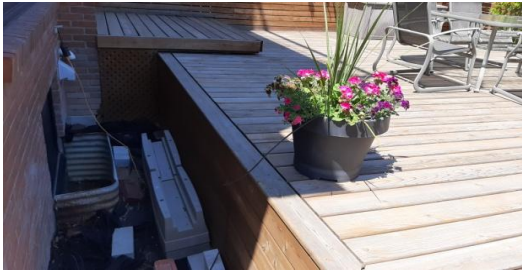
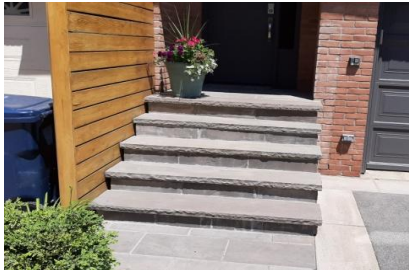
</div> <p>DECK(s): overall in good repair, recommend safety rails at edges and steps</p> <p>PORCH overall in good repair, recommend safety rails to steps</p> <div>

</div>			
<p>Note: Maintain Gutters & Downspouts annually. Extend Downspouts at least 6-feet away from the house</p> <p>** Any or all these items may contribute to Basement Leakage. Please see Interior Form</p>

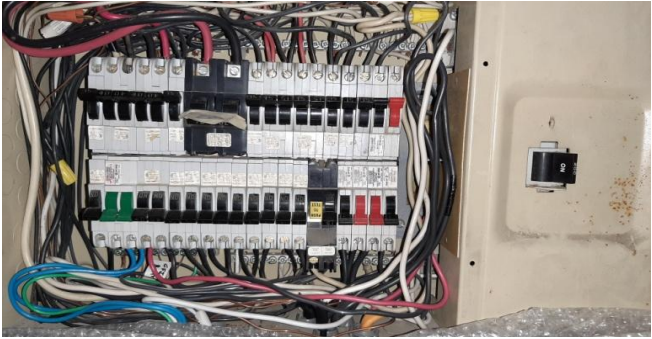
<div>REDBRICK INSPECTIONS LTD.</div> </div> </div>	
		June 16 2020	
Description			
Service Size:	200	AMP (240volts)	Service Entrance Cable:
Main Disconnect/Service Box			Distribution Wire:
Rating:	200	AMP	Location: Underground
Description:	Breakers	Type of material:	Copper
Location:	Garage		Grounded
Distribution Panel		System Grounding:	
Rating:	100	AMP	Description: Copper
Description:	Breakers	Location:	Water Pipe
Location:	Garage		Ground Fault Circuit Interrupter:
Auxiliary Panel(s):		Outlets	Location: Outside Panel
Rating:	60	AMP	Bathroom(s)
Description:	Breakers	Description:	Kitchen
Location:	Garage	Number of Outlets:	Arc Fault Circuit Interrupter:
		Typical	Location:
Limitations			
Main Disconnect Cover Not Removed			
Ref#*	Observations/Recommendations		
<p>SERVICE PANEL: crowded though overall in good repair</p>

<p>Note 1: All recommendations are safety issues - Treat them as high priority.</p> <p>Note 2: Please ensure accurate labelling on panels.</p>

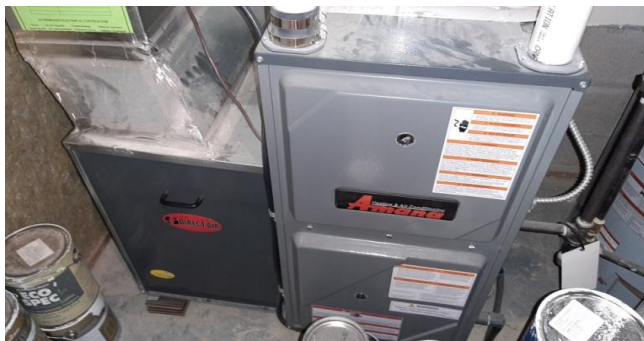
FORCED AIR FURNACE: [service annually](#)

Filter: [replace 1-per-6 to 12 months](#)

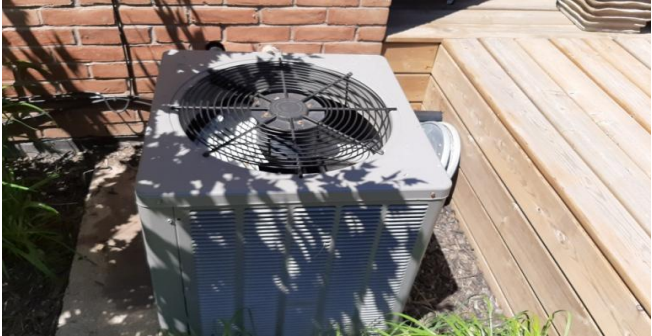
June 16 2020	
Description			
Description:	Cooling Capacity:	Approx. Age:	Typical Life Expectancy:
Air Conditioner (air-cooled):	24 x1,000 BTU/hr	15 yrs. old	15 to 20 yrs.
Limitations			Cooling Performance
			Supply Temp F: 55
			Return Temp F: 70
Ref#*	Observations/Recommendations		
<p>AIR CONDITIONER: aging unit, continue servicing until replacement becomes necessary</p>

<p>3rd level typically more difficult to cool- may require supplemental unit</p>

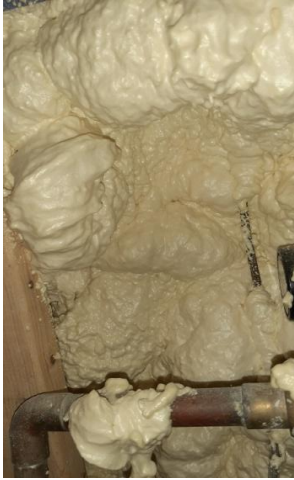
REFERENCE LINK		http://redbrickinspections.ca/docs/8_Insulation_Ventilation_Guide.pdf		
79 Beaconsfield Ave		INSULATION/VENTILATION		June 16 2020
Description				
Material:	Location	R-Value	Air/Vapour Barrier:	Venting:
Spray foam:	Basement Walls:	24	Not Visible	Roof Roof Ridge Roof Ridge
Limitations				
Access Not Gained To Wall Space		Access Not Gained To Flat Roof		
Access Not Gained To Roof Space		Basement Walls Spot Checked Only		
Ref#*	Observations/Recommendations			
<p>Basement Walls: spray foamed walls which is above average</p>
