# HOME INSPECTION REPORT

8 Wareside Rd  
Toronto

Inspection Date: March 29 2016

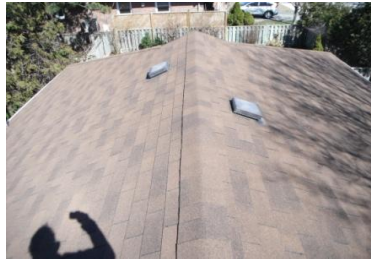
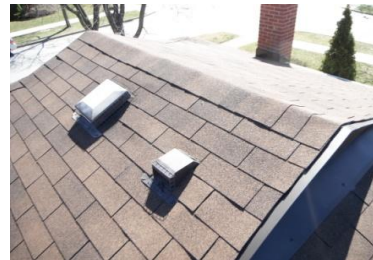
Sloped Surface: overall surface in good repair, minor staining observed on underside of lower roof - monitor

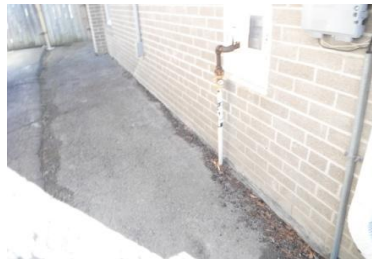
\*\*Walk(s): seal gaps at wall around perimeter to minimize moisture in basement

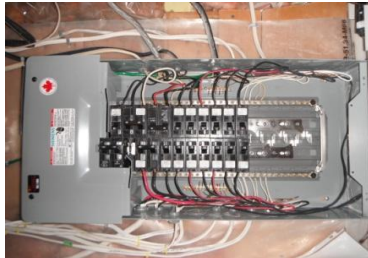
**Observations/Recommendations**SERVICE PANEL: **upgraded**

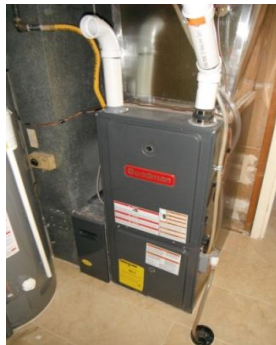
FORCED AIR FURNACE: service annually

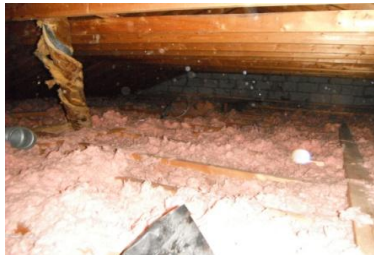
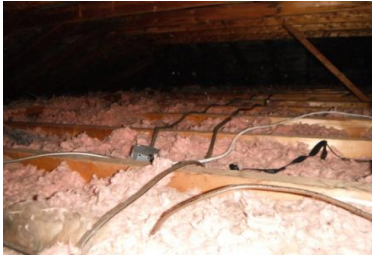
Description				
Material:	Location	R-Value	Air/Vapour Barrier:	Venting:
Fiberglass:	Main Roof:	18	Kraft Paper	Roof
Fiberglass:	2nd Roof:	18		
Limitations				
Roof Space Inspected from Access Hatch				
Ref#*	Observations/Recommendations			
	ROOF SPACE: low insulation, uneven in some areas, recommend upgrading and installing soffit vents			
	Roof Access Hatch: insulate and weather-strip access hatch to roof space			
	<div>

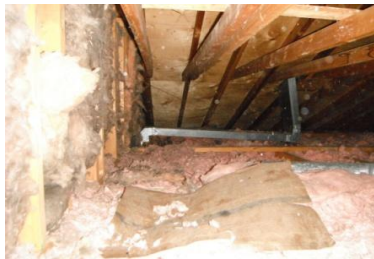
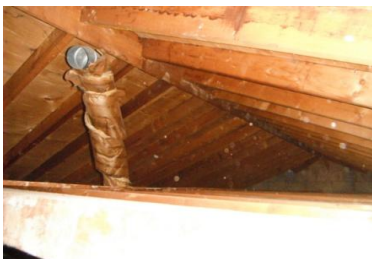
</div>			
	Exhaust Fan Vents: recommend insulation kitchen vent, remove abandoned duct			
	<div>

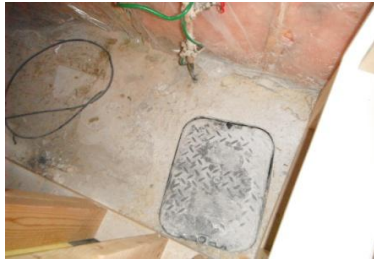
March 29 2016		page 9	
<b>Description</b>									
Service Piping into House:		Main Shut Off Valve at:		Water Flow (Pressure):					
Copper		Basement		Adequate					
Supply Piping & Pump(s):		Waste Piping & Pump(s):		Water Heater					
Copper		Plastic							
Plastic		Cast Iron		Type: Conventional					
		Copper		Fuel Type: Gas					
				Capacity: 40 Gal					
				Age Yrs.: 3					
				Life Expectancy: 15					
<b>Limitations</b>									
Isolating/Relief Valves & Main Shut Off Valves Not Tested				Concealed Plumbing not Inspected					
Kitchen and Laundry Appliances Were Not Inspected				Tub/Sink Overflows Not Tested					
<b>Observations/Recommendations</b>									
<p>WASTE PIPING:</p> <p>Basement Floor Drain: not found - further evaluation required, also none found for crawl space</p> <p>Laundry Floor Drain: as above</p> <p>Piping: main waste drain includes a newer backflow valve</p> <div data-bbox="587 1052 958 1310">
