HOME INSPECTION REPORT

901 College Ave
Toronto

Prepared by: Bob Papadopoulos P.Eng., RHI *

Inspection Date: June 28 2017

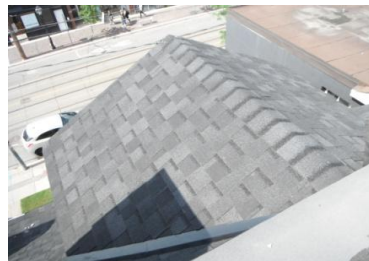
Sloped Surface: **new surface in good repair**

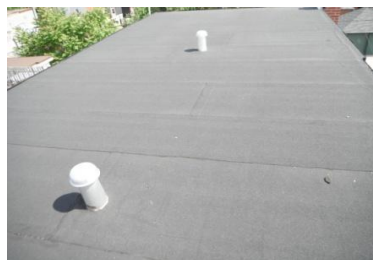
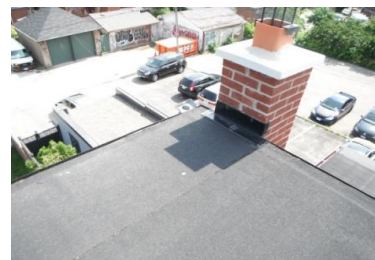
Flat Surface: **new surface in good repair, may require additional scupper drain at rear upper flat area**

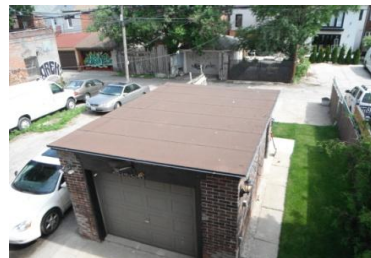
Garage: **new surface in good repair**

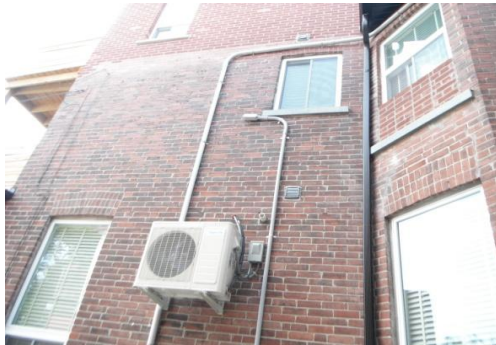
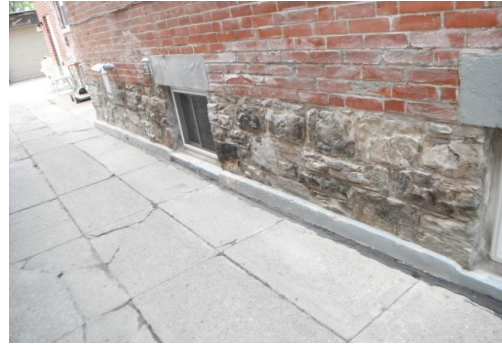
WALL SURFACES: overall in good repair
Soffit & Facia: newer and in good repair
**Gutters/Downspouts: newer and in good repair
DOORS/WINDOWS: overall in good repair

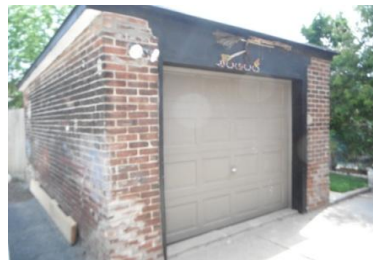
DETACHED GARAGE: overall appears to be well built

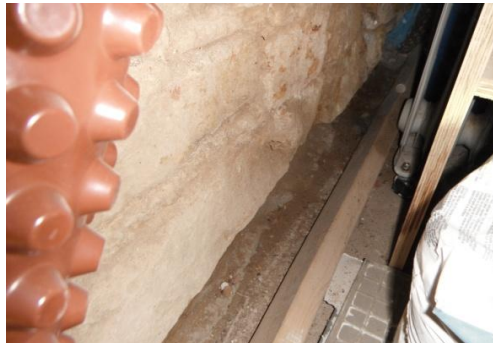
FOOTINGS/FOUNDATIONS rear basement under steps, portion of foundation at bottom is missing, requires repair to avoid risk of settlement

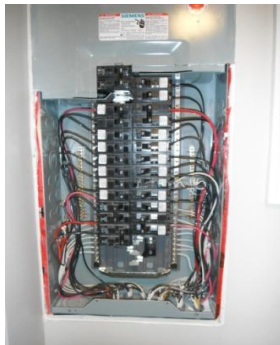
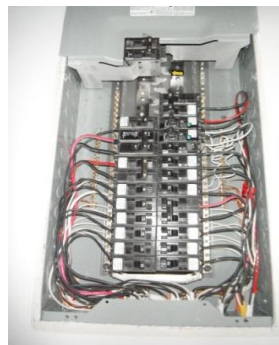
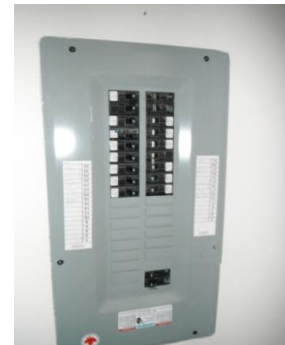
SERVICE PANEL: **three new panels for each unit**

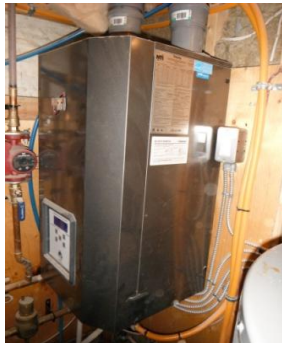
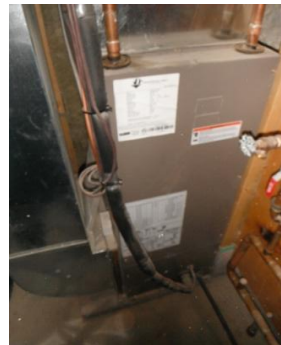
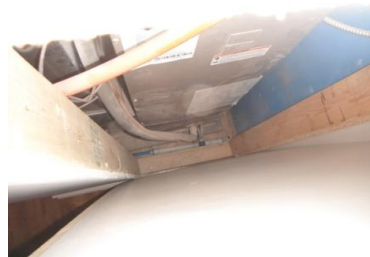
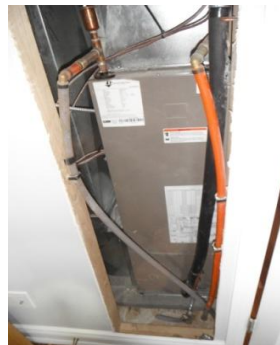
HOT WATER BOILER: unit provides hot water to three forced air-handlers (heat exchangers)
service annually
replace filters every 3 months for air-handlers (service annually)
1st level: should make unit more accessible (i.e. hinged door)

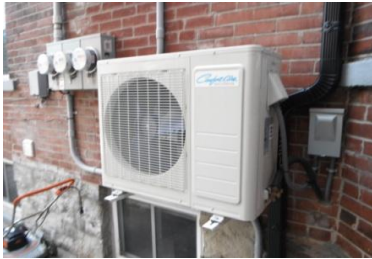
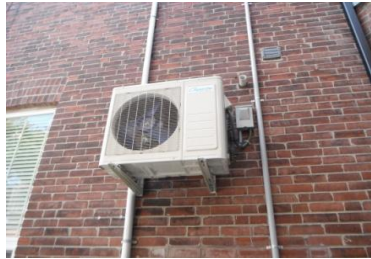
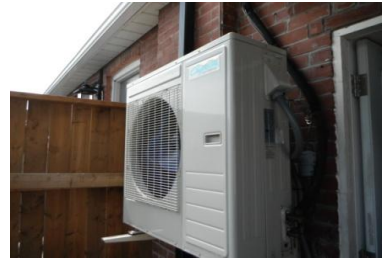
AIR CONDITIONER: [three units - service annually](#)
