HOME INSPECTION REPORT

958 Ninth St
Toronto

Prepared by: Bob Papadopoulos P.Eng., RHI *

Inspection Date: Nov 10 2021

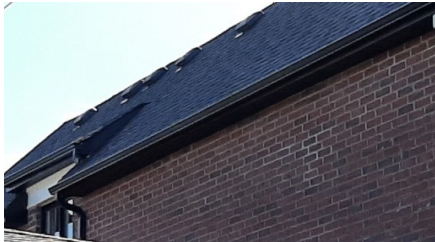
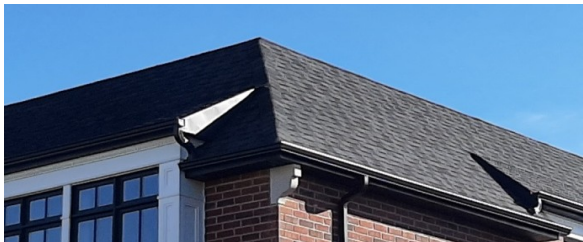
REFERENCE LINK		http://redbrickinspections.ca/docs/2_Roofing_Reference_Guide.pdf	
958 Ninth St		ROOFING/Chimneys	
		Nov 10 2021	
Description			
Roofing Material:	Location:	Leakage Probability:	Chimney(s) Type: Location:
Asphalt Shingles:	Slope:	Low	
Not Determined	Flat:	Low	
Modified Bitumen:	Porch(s):	Low	
Limitations			
Roof Inspected By:	Access Limited By:	Chimney Access Limited By:	
Binoculars	Height		
Observations/Recommendations			
<p>Sloped Surface: new surface in good repair</p> <div style="display: flex; justify-content: space-around;">

<p>Note: Recommend Annual Maintenance Contract for Roof Surface, Flashing Details and Chimney(s)</p>

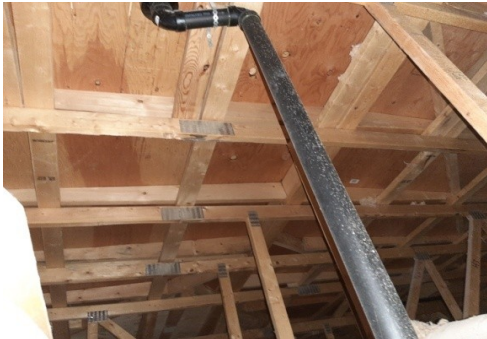
</div> <p>Flat Surface: not accessible, no signs of leaking as observed from under roof space</p>

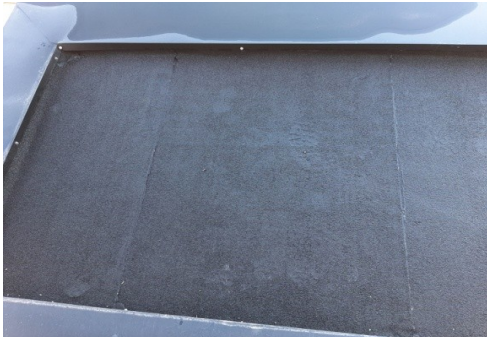
<p>Porch(s): new surface in good repair</p>

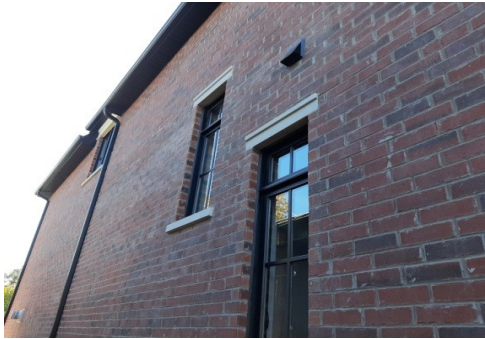
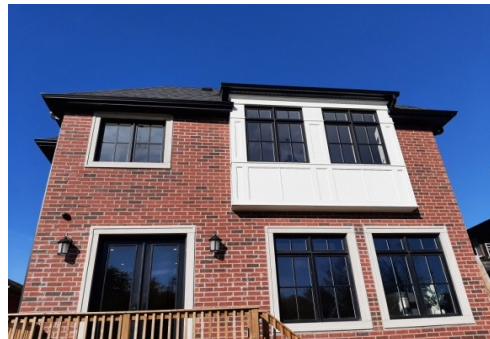
WALL SURFACES: newly installed

DOORS/WINDOWS: newly installed

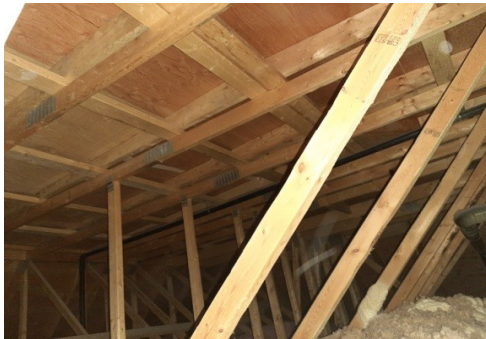
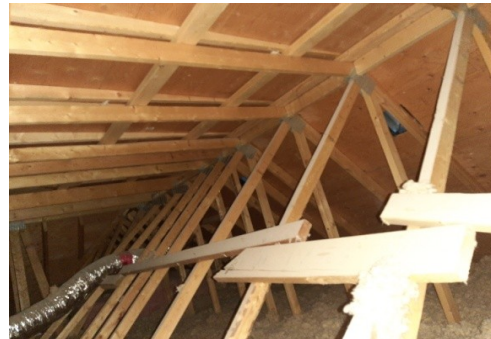
ROOF: overall in good repair

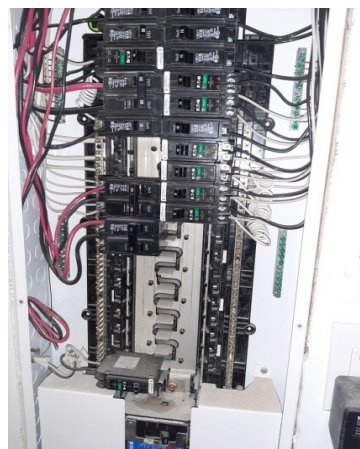
Limitations**Main Disconnect Cover Not Removed****Observations/Recommendations**SERVICE PANEL: **overall in good repair**

Note 2: Please ensure accurate labelling on panels.

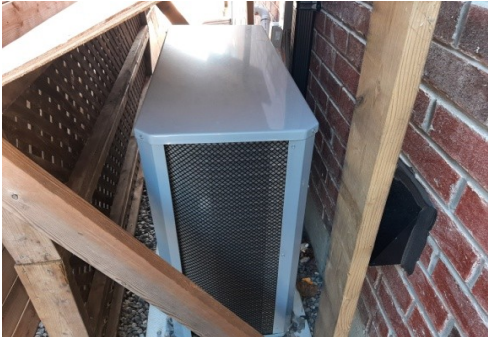
REFERENCE LINK	http://redbrickinspections.ca/docs/7_AC_Heat_Pump_Reference_Guide.pdf		
958 Ninth St	COOLING/Heat Pumps		Nov 10 2021
Description			
Description:	Cooling Capacity:	Approx. Age:	Typical Life Expectancy:
Air Conditioner (air-cooled):	30 x1,000 BTU/hr	1 yrs. old	10 to 15 yrs.
Limitations			Cooling Performance
Cannot Test With Low Outdoor Temp			Supply Temp F: Return Temp F:
Observations/Recommendations			
<p>AIR CONDITIONER: not tested: should be serviced before using</p>

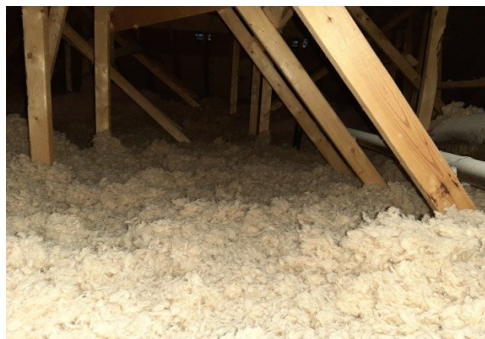
ROOF SPACE: insulation (above average) and ventilation is adequate
